Evaluation of Safety Performance of Fractured Joints in Steel Truss Bridge

Abstract

Keywords: highway bridge; HSFG bolts; modes of failure.

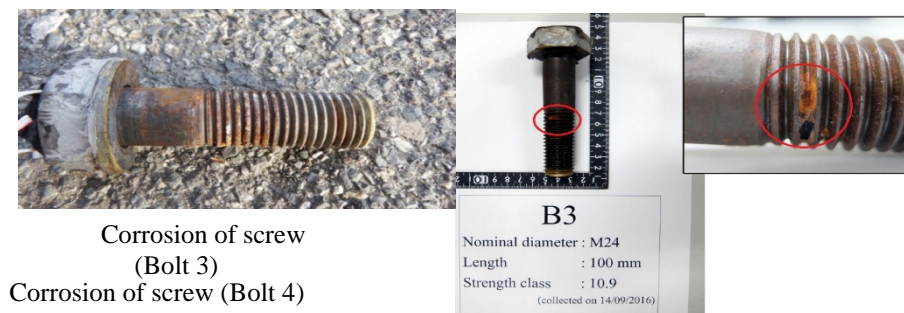
Figure 6: Corrosion of high strength bolts

- The fundamental frequencies of some modes of the bridge were found to be around 1.4 Hz, 2.6 Hz and 3.2 Hz by converting the vibration data to FFT graphs (see Figure 5).
- The average values for the wind speed, temperature, relative humidity and atmospheric pressure were measured as 1.9 m/s, 32.6°C, 62.8%, 996 hPa respectively.
- Bolt axial forces are shown in Table 5. According to the Japanese standard and AASHTO, the introduced bolt axial force for bolt of which diameter is 24mm and strength class is F10T or 10.9 should be 238kN and 257kN respectively. Bolt axial force of Bolt 3 and 4 are less than the other bolts due to corrosion (see Figure 6).

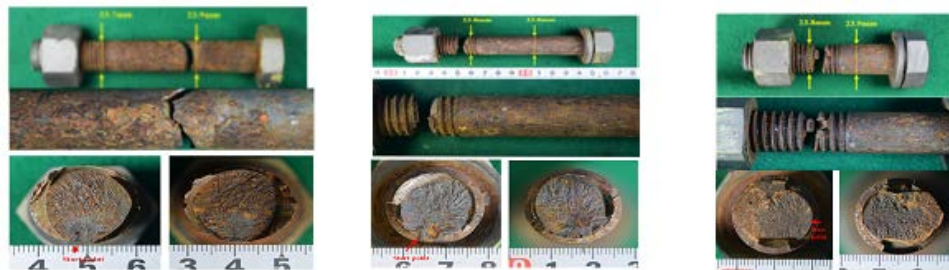
Figure 8: Observation of appearance of high strength bolts

Radial fractures occurred in the cylindrical part of Bolt A and in the thread root of Bolts B and C.

These bolts show no conspicuous deformation, such as bending or a change in diameter.

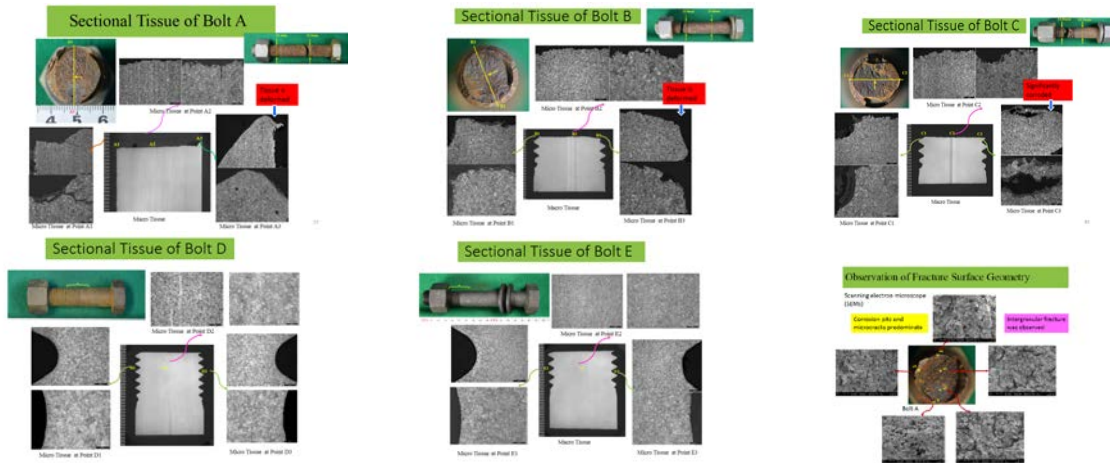
Figure 9: Sectional tissue of high strength bolts

Although the fracture surface geometry is obscured by corrosion, intergranular fractures are present. A number of corrosion pits and microcracks can be seen.

- Furthermore, the tissue is uniform and has no defects, such as large inclusions, that could become the starting point of fracture.
- These findings indicate that the damage to the hexagonal bolts was caused by delayed fractures.

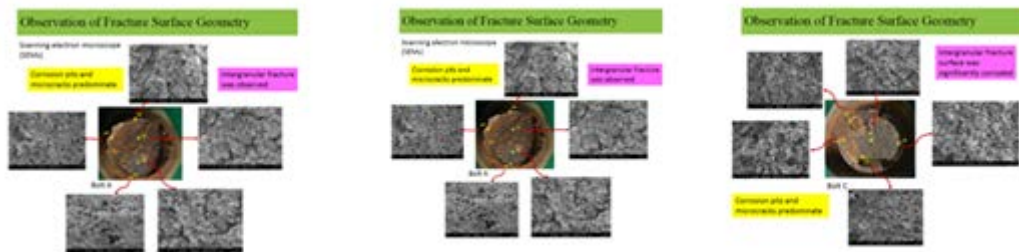
Figure 10: Observation of Fracture Surface Geometry

Fracture surface is completely rusted and a number of microcracks and corrosion pits are visible. Although some parts are obscured by corrosion, the fracture surface is chiefly that of intergranular fracture. This resembles the characteristics of a delayed fracture.

- Fracture surface is completely rusted and a number of microcracks and corrosion pits are visible. Although some parts are obscured by corrosion, the fracture surface is chiefly that of intergranular fracture. This resembles the characteristics of a delayed fracture.

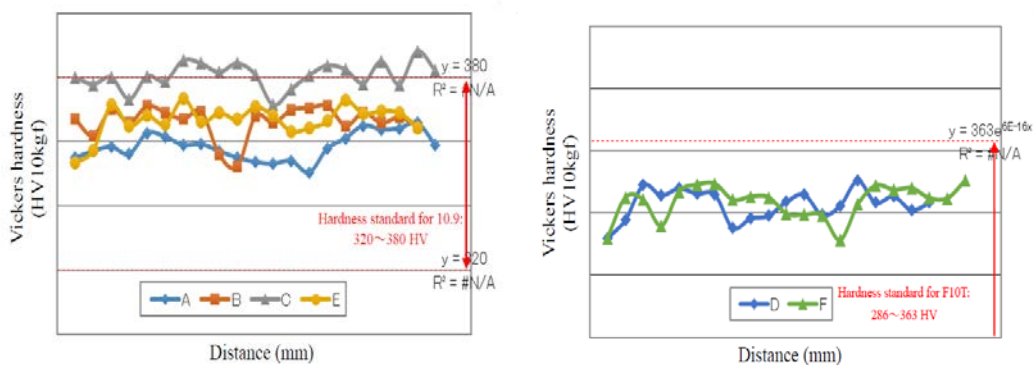
Figure 11: Hardness testing of high strength bolts

The hardness values for Bolts A-C and E are 352-388 HV. Only some of the hardness values for bolt C exceed the standard upper limit for the standard hardness values for the strength category of 10.9 (320-380 HV). The hardness values of Bolt D and F are 331-350 HV, which differ from those for Bolts A-C and E. The hardness values for the washers are 400-429 HV. The Standard hardness values for washers in the strength category of 300 HV range from 300 to 370 HV (washers from Bolts A-C ad E). Their values exceed the upper limit of the standard.

- Moreover, some of the measured values for Bolt C, one of the fractured bolts, exceed the standard upper limit (equivalent to the value of F11T). The measured values for Bolts A and B also are near the upper limit of the hardness standard for bolts in the strength category of 10.9.

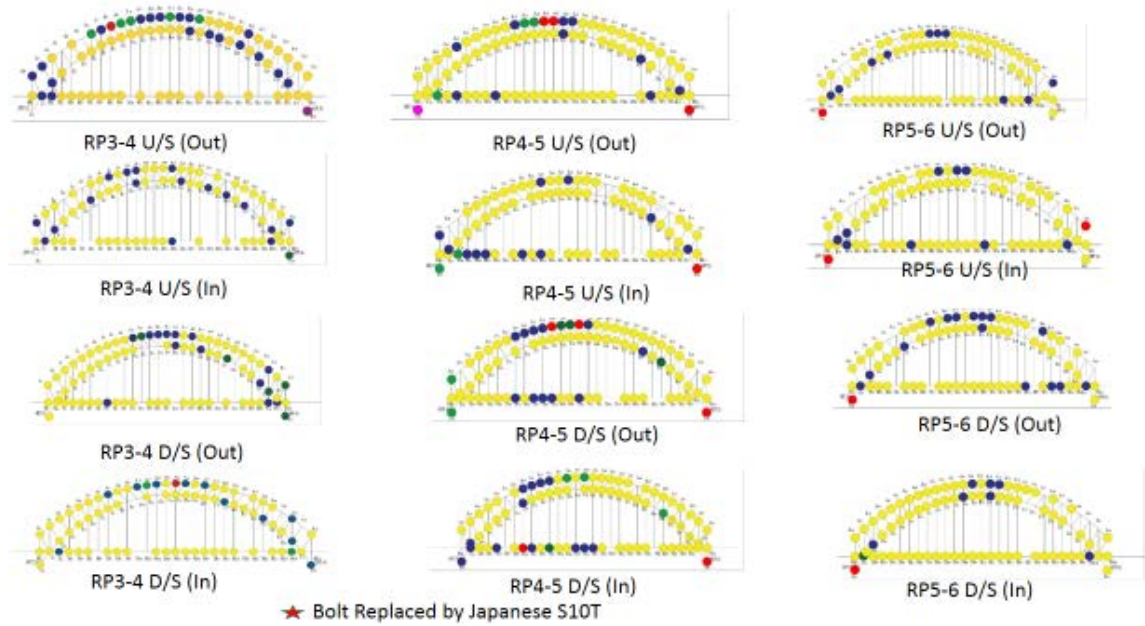
Figure 12: Damage pattern of fractured high strength bolts

According to preliminary analysis of the quantities, location and picture of the fractured HSBs based on maintenance records [5], the fracture occurs in the whole bridge and at random, in disorder and at a wide range.

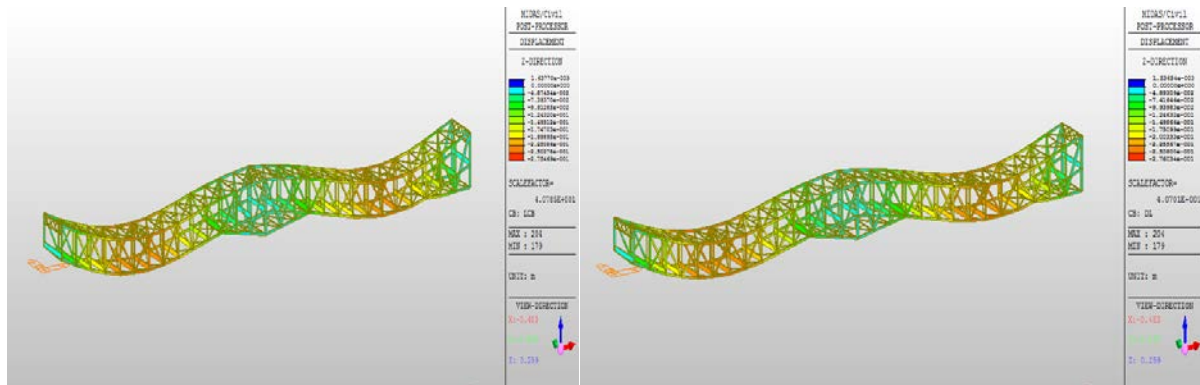
Figure 16: Deflection due to dead and service load of truss bridge

The maximum vertical (Z-Direction) deflections at mid span due to dead load and service load of truss bridge (Figure 16) is 0.27 m and that of arch bridge (Figure 17) is 0.3 m. Both are exceeding the allowable limits of $L/360$.

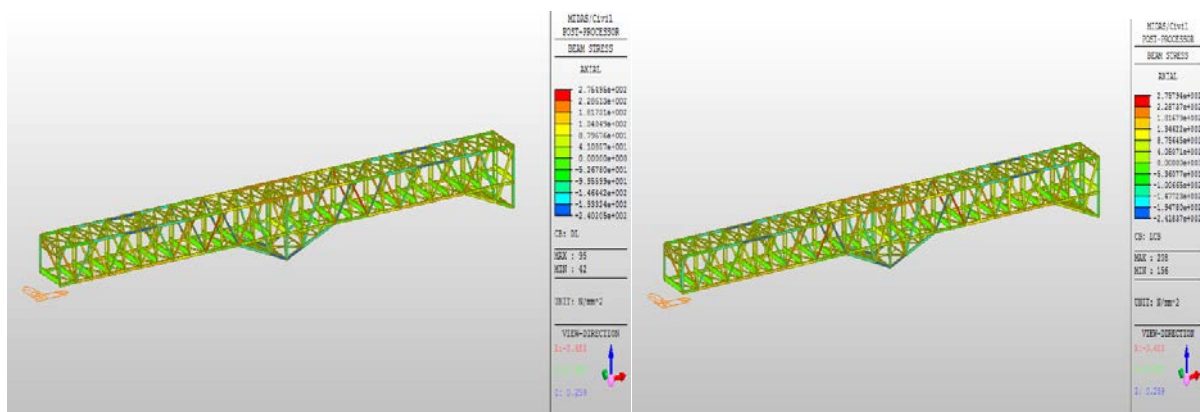
Figure 18: Stress due to dead and service load of truss bridge

Maximum stress of truss bridge (Figure 18) for dead load and that of service load is 275 MPa. For arch bridge (Figure 19) maximum stress for dead load is 158 MPa and that of service load is 248 MPa. Allowable stress is 370 MPa and stresses are within allowable limits.

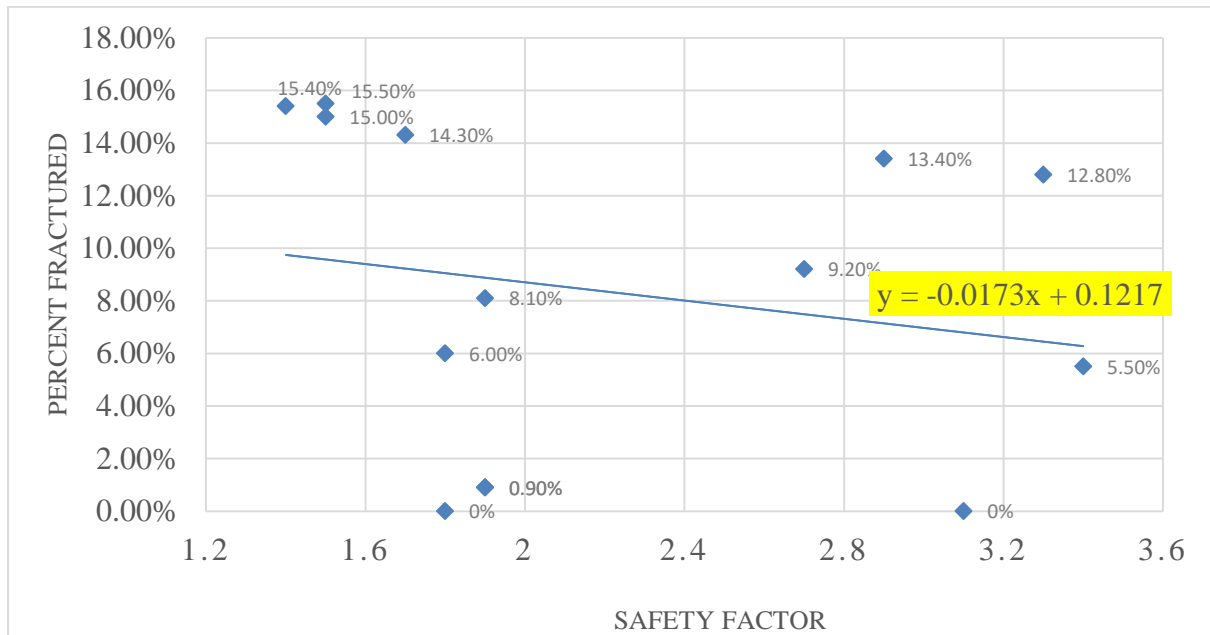
Figure 21: Safety performance of fractured joints

It can be seen that percent fracture decrease as safety factor increase (see Figure 21).

- Based on evaluation of safety factor of fractured joints, percent fractured relates to safety factor of joints and more fractured joints are occurred factor of safety less than 2. Safety factor of joints must be careful in connection design of steel bridge and safety factor should be at least 2.
