REAR AXLE FAILURE ANALYSIS OF THE DUMP TRUCK

Abstract. The dump truck rear axle has failed while operating. The shaft transmits torque from the differential gear to the rear wheels through a planetary gear arrangement. Axle parts that fail to be investigated to determine the cause of failure. Field scanning is done using scanning electron microscopy (SEM). The hardness profile along the cross section is evaluated by measurement of micro hardness. Chemical analysis shows that the shaft is made of american iron steel institute (AISI) 4140 steel. The shaft carbon content is 0.52%, higher than AISI 4140 standard where the maximum carbon content is 0.45%. Manganese (Mn), sulfur (S), phosphorus (P), silicon (Si), and chromium (Cr) content have met standards. Microstructure analysis and profile hardness testing revealed that the edge profile was more fragile, different from the more resilient core. This phenomenon is related to the discovery of microstructure on the edge of the profile found in a martensitic structure which reveals that the manufacturing of the shaft undergoes a surface hardening process to harden the shaft surface. The analysis shows that the fracture starts from the ed

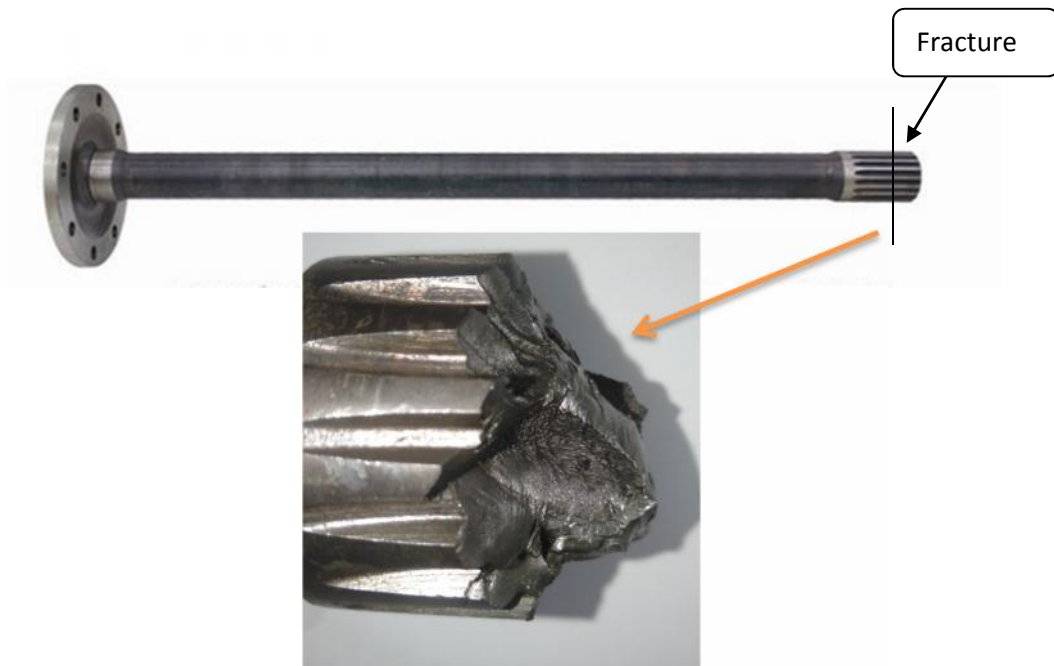
content of less than 0.25%, medium carbon steel containing 0.25 - 0.6% carbon, and high carbon steel containing 0.6 - 1.4% carbon [3]. The rear axle shaft uses a medium carbon steel type. Figure 1 (a) and figure 1 (b) are examples of rear wheel shafts that are still good and which have been damaged.

Figure 1. The broken of the axle shaft whos connected with a differential gear

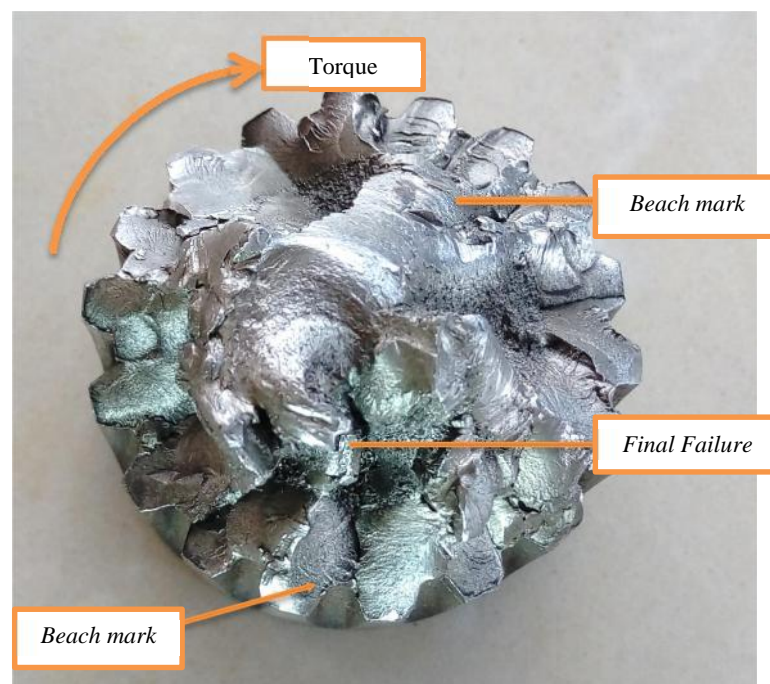
From the results of the macroscopic analysis it is seen that the crack initiation on the shaft starts from the edge of the shaft towards the center of the shaft as evidenced by the shape of the spiral in the center of the shaft that has failed. In the figure 2. there is a beach mark that is evenly distributed from the edge to the center of the shaft and the combination of slow crack propagation (dull and fibrous areas) and rapid crack propagation (areas that are shiny and slippery) indicates the shaft accepts dynamic loads.

Figure 2. cross section of broken shaft

The crack initial is indicated by striation and beach mark in the area around the crack initiation at the fault edge and appears to be rougher, while the beach mark is indicated by fine semi-circular lines in the initial crack area to final failure. Beach marks also called to be crack propagation stages. The area between the crack propagation stage and the final stage can quantitatively show the magnitude of the stress acting. If the area of the crack propagation area is greater than the area of the final fracture, the working stressing is relatively low, and vice versa if the area of the crack propagation is smaller than the area of the final fracture, the working of the stressing is relatively higher. Phase one occurs metal fatigue, which is the initial stage of crack formation, is easier to occur in metals that are soft and resilient but will be more difficult in the crack propagation stage (Phase two), meaning that ductile metals will be more resistant to crack propagation. Likewise, the hard and brittle metal will withstand the initial formation of the crack but is less resistant to crack propagation. The stages of initial crack formation and crack propagation in the metal fatigue mechanism require time so that the fatigue life of the component or metal is determined from the two stages. The crack grows small to the

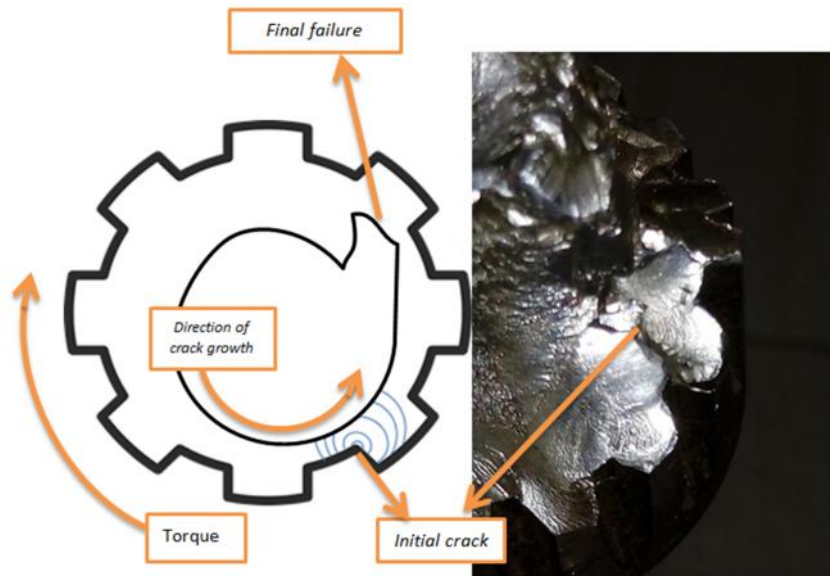
Figure 3. Initial Crack and Direction of Crack Growth

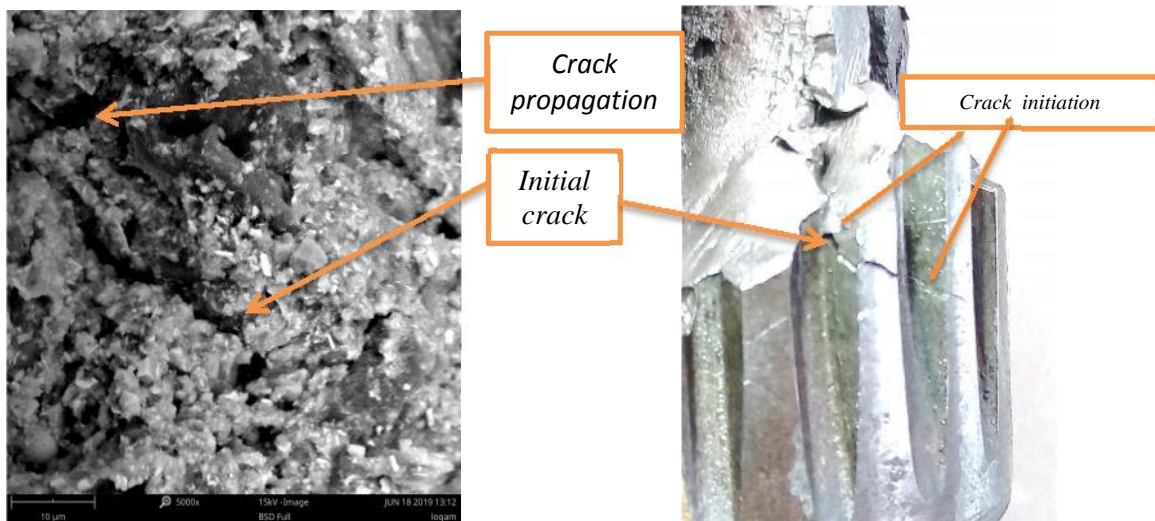
Figure 4. Crack Initiation and Crack Propagation

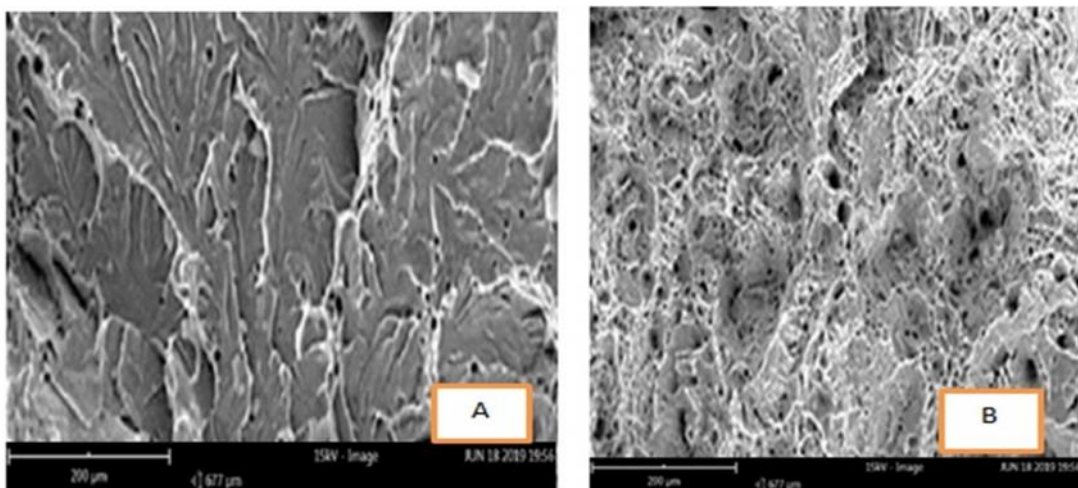
Fractography on the surface of the shaft can be seen as a V-shaped cleavage on the surface fracture, certainly broken because on brittle mode. While the fracture on the core of the shaft shows the shape of the dimples on the fault. Ascertained is an elastic type of fault. The fracture surface assessment identified several characteristics of fatigue failure characteristics: (i) a beach mark sign that is a sign of development of fatigue front cracks and (ii) a ratchet mark which is a sign of crack initiation due to high stress concentration. The exact mechanism of fatigue is always consistent with unidirectional bending [6].

Figure 5.1 (A) Fractography analysis of the edge of the failed component; (B) fractography analysis of the core of the failed component.

The shape of the shaft fracture surface on the outer diameter and inner diameter shows differences in fracture characteristics from the SEM test analysis, where the broken surface area of the outer diameter is relatively flat with beach mark lines and V shape and there is cleavage on the shaft indicating the tough outer shaft but brittle / brittle and the fault diameter area of the dimples pattern has plastic deformation indicating the inner diameter of the shaft is more resilient.

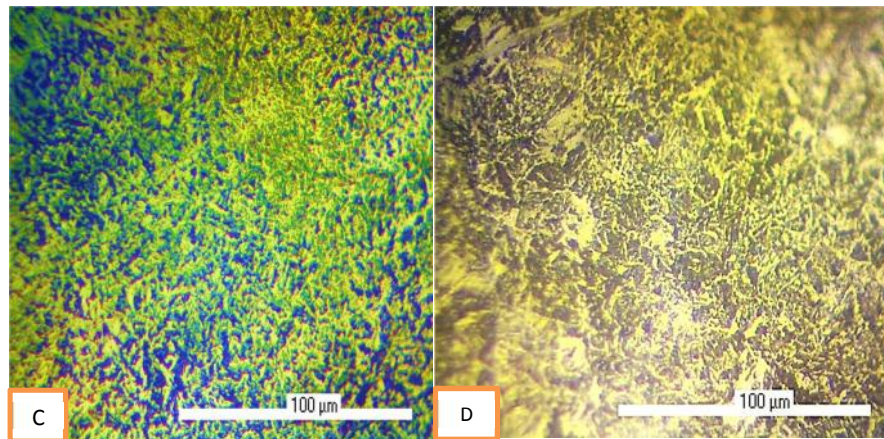
Figure 5.2 (C). Microstructure of the edge of the component 600x, (D). Microstructure of the core of the component 600x

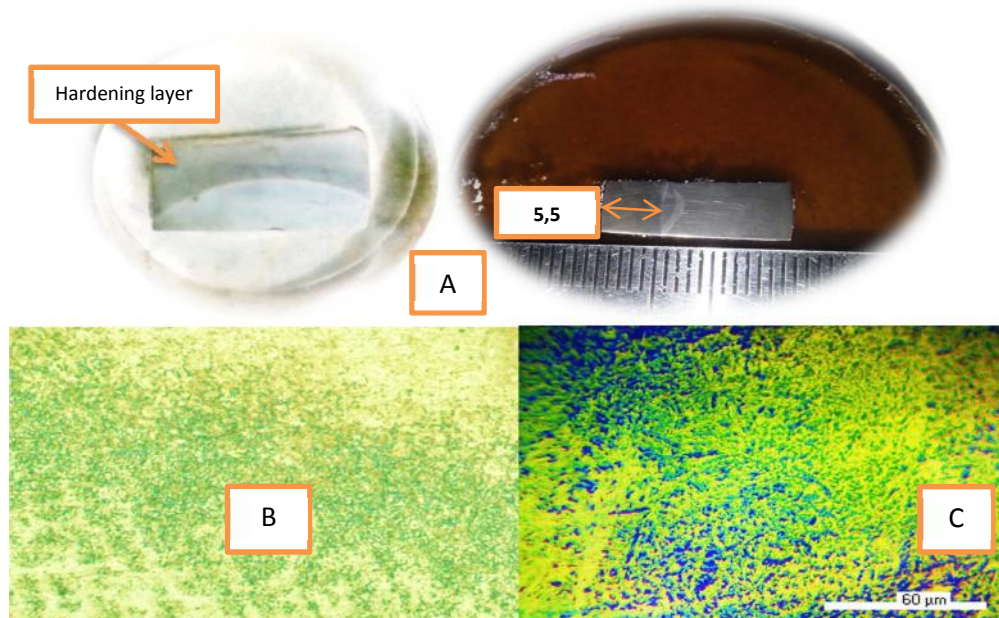
Microscopic analysis on the shaft surface, figure 39. and figure 43. show that the martensite phase is uneven tends to be grouped. There is a ferrite-pearlite phase on the sidelines of a martensite group, indicating the temperature at the surface hardening process is unstable. The matrix area shows that the dominant martensite phase is rough and sharp so that it can be concluded that tempering is carried out at high temperatures and quite a long time and is quenched quickly. This grouped and uneven martensite phase results in uneven surface hardness of the shaft.

Analysis of the core of the shaft, shows the dominant ferrite and pearlite phases. It was concluded that the core of the shaft was more resilient than the surface of the shaft which was dominated by the hard bainite and martensite phases.

Figure 6. (A). Macrostructure of the cross section of the failed shaft, (B). Microstructure of the edge of the component 50x, (C). Microstructure of the edge of the component 600x

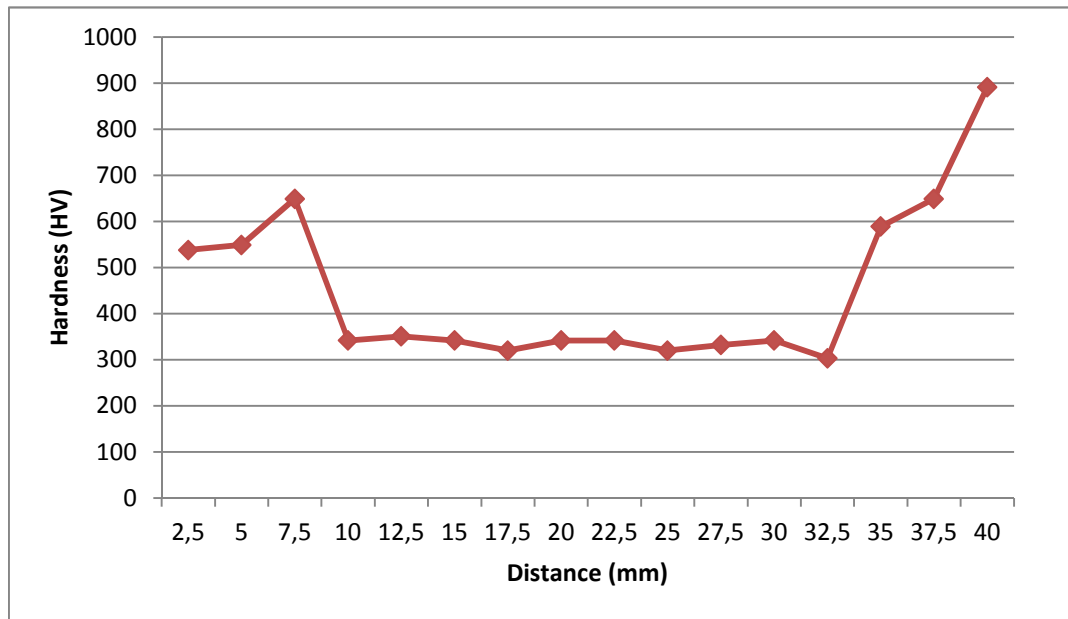
Figure 7. Rear Axle hardness distribution A

The distribution of the hardness values observed in Figure 7 does not look uniform. Surface hardness on different left and right sides is different, namely 538 HV and 891 HV indicating that surface hardening is not evenly distributed on the shaft.

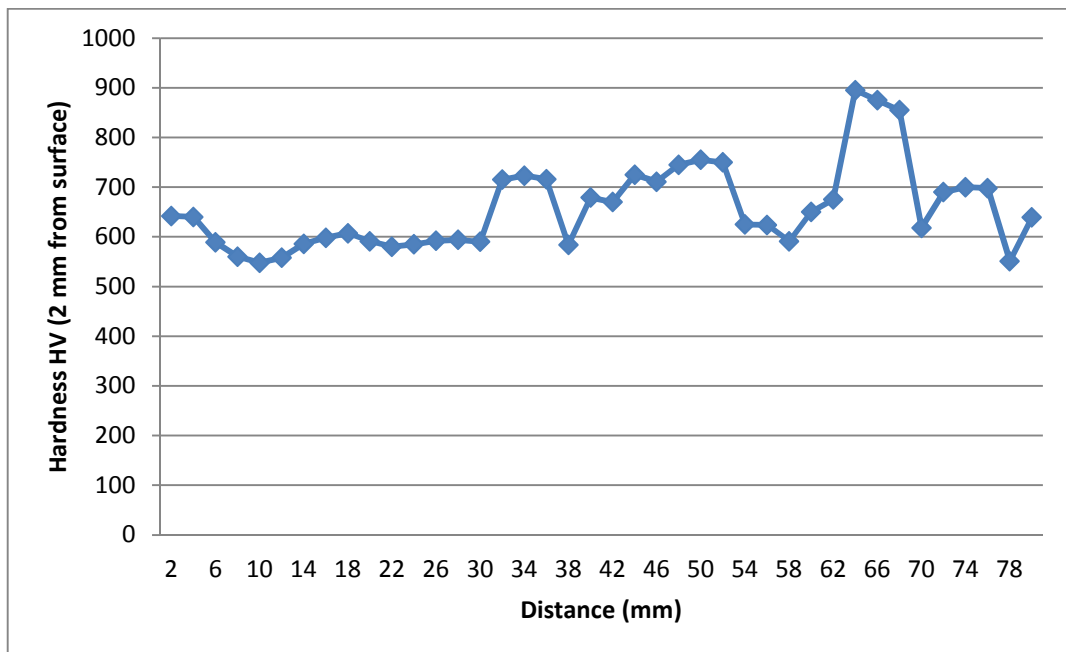
Figure 8. Rear Axle hardness distribution B

The distribution of the hardness value observed in Figure 8 There is a fluctuation in the value of hardness which is tested 2 mm from the edge (surface) by 40 circular points

using a Vickers hardness tester. The highest hardness value is 885 HV and the lowest is 548 HV.
