Pavement Assessment of Farm Roads in Bhutan

Abstract

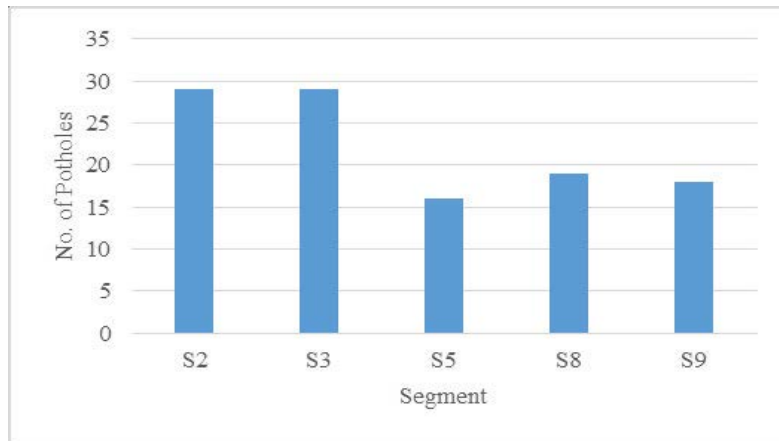
Figure 1: No. of Potholes

Rainfall and traffic were observed to be the main triggering factors for formation of potholes. The number of potholes, maximum and minimum depth of potholes in most affected portions are shown in Figure 1 and Figure 2.

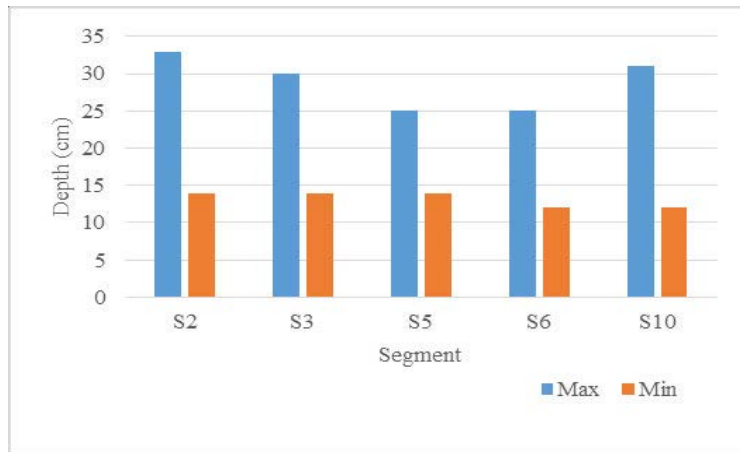
Figure 3: Depth of ruts

The parallel depressions along the most affected segments were observed to be the causes of inadequate compaction of the pavement surface during the time of construction. The condition is worsened by wet clay and silt soils in some segments of R2, which are loosened by ponding of water, and get displaced laterally under traffic load. The non-cohesive soil in effected segments of R1 are also displaced laterally under traffic load. The maximum and minimum depth of ruts in most affected segments are shown in Figure 3.

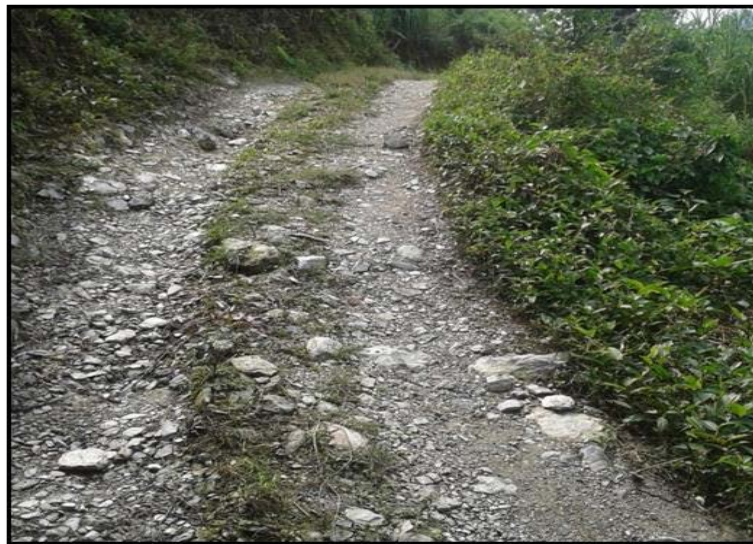
Figure 4: Rut formation in R1

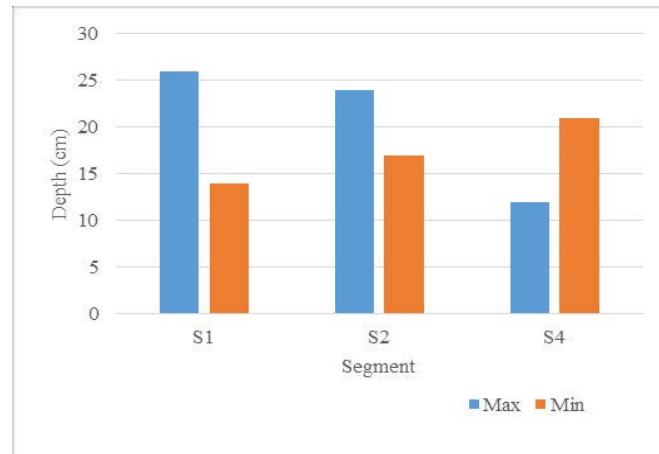
Figure 5: Depth of erosion track

Erosion tracks were prominent in R1 and R2, where rainfall intensity was high as compared to that of R3. The

irregularity of the pavement surface, and vertical gradient as high as 10% were observed to be the contributing factors to the erosion of surface materials in some of the segments in R1. The absence of side drains, subsidence of the pavement surface and absence of cross-fall were the causes observed for the erosion in R2. In R3, the absence of side drains was prominent issue for surface erosion. The maximum and minimum depth of erosion tracks in most affected segments are depicted in Figure 5.
