An Investigation on the Premature Failure of Spur Gear in Coal Stacker Reclaimer: Mechanical Properties and Microstructure Analysis

Abstract

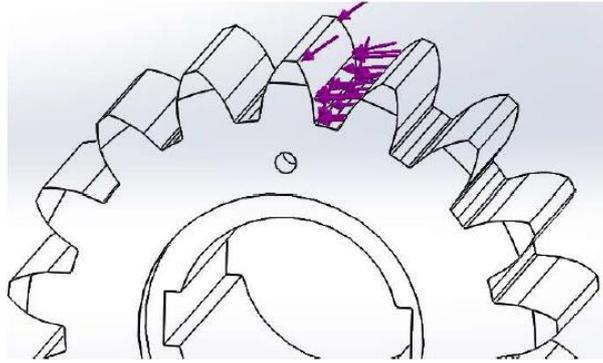
Figure 2 shows the configuration of driving and the driven gear whereas the precise dimensions of the driving gear is depicted in Figure 3 and Table 1. Based on the pinion gear motion in Figure 2, the force diagram acts on the driving gear related to the direction of the applied load is presented in Figure 4 which can be predicted as the initial/origin of crack propagation which resulted in gear failure.

Figure 4: Force diagram in 3D model

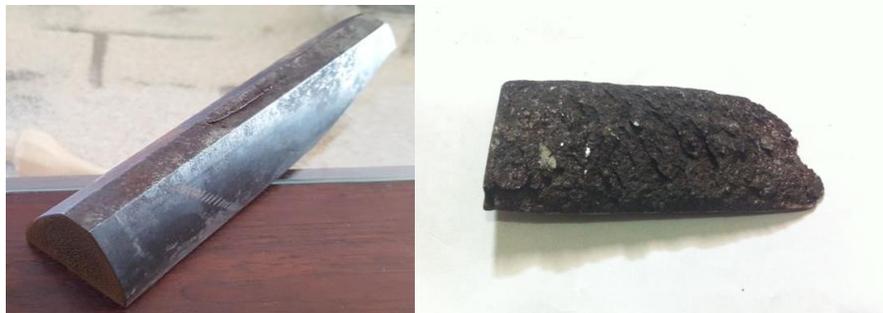
Based on the visual inspection, the driving gear received a heavy load which concluded based on the shape of the failure in Figure 5. The direction of the failure starts from the a gear surface, propagates to the center, then failed with a brittle pattern which push a part of a gear tooth seperated form the main gear body. The failed part is depicted in Figure 5. The gear get palstic deformation before the failure occurs. According to Dieter [12], brittle fracture is indicated by the direction of origin of the crack and the crack propagation path. The direction of the failed component and the shape of the fault surface are shown in Figure 6-7.

Figure 5: Fault spur gear (left) and Fracture surface of fault spur gear (right)

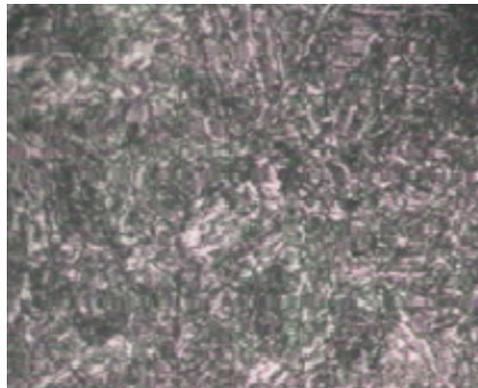
The martensitic structure in the spur gear tooth specimen is shown in Figure 6-7. The image shows that the microstructure of the gear corresponds to the martensitic phase. At a depth of 10 mm, as shown in Figure 7 below the surface of the specimen, the martensitic structure begins to decrease and some fields consist of ferrite-pearlite structures.

Figure 6: Microstructure on the surface of the specimen which get the contact during the gear works, with 500X magnification

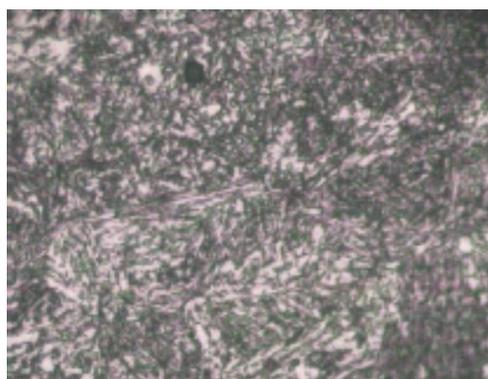
Figure 7: Microstructure of the inside of the specimen which located below the loading surface, with 500X magnification

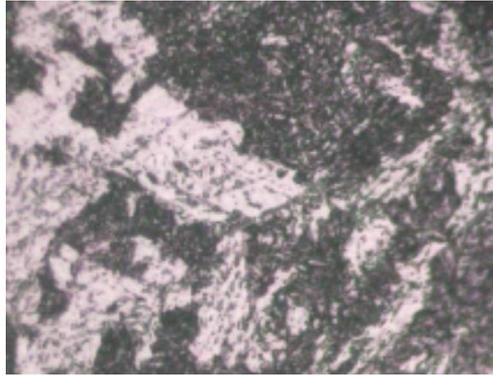
In addition to the martensitic structure, a ferrite-pearlite structure is formed in some of the fields shown in Figure 8. This shows the difference in hardness and structural inequality which can cause an indication of the cause of cracks or faults. Hardness in the fault area will be carried out in the next test.

Figure 8: Microstructure of the failed gear using 500X magnification which show a ferrite-pearlite microstructure.

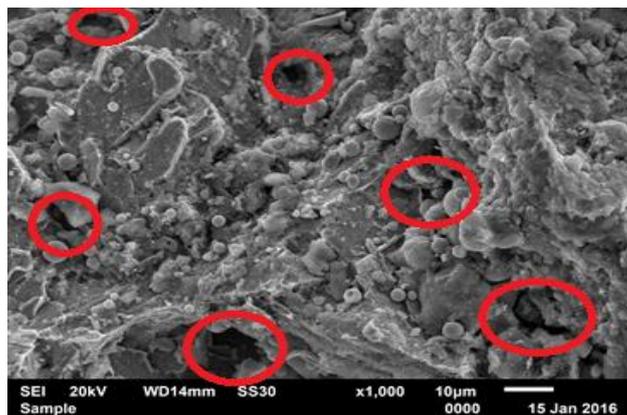
Observation with SEM on the surface of the spur gear fracture specimen is shown in Figure 9. The image shows some porosity pointed with red marks and grain size disparities that can cause dislocation to form. According to Dieter [12], grain boundary irregularities can lead to the emergence of dislocations.

Figure 9: SEM on the surface of the spur gear fault

Based on the previous test, the failure which occur in the spur gear may be caused by defects found inside the gear. This defect is proven by observations with an optical microscope, SEM and hardness test. The appearance of several porosities and grain uniformity causes the formation of dislocations at the grain boundary, with a large amount of dislocation inside the gear will perform a failure.

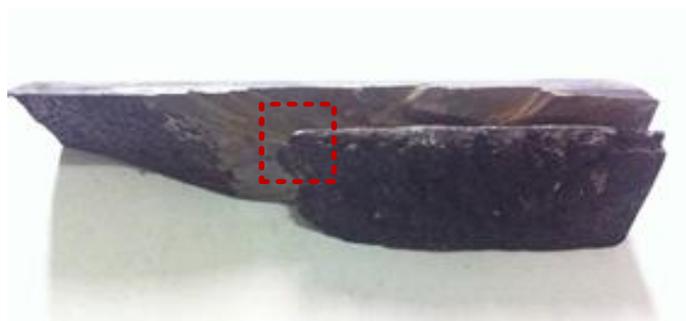
Figure 10 shows the part which failed and separated from the main body of the driving gear. This part is then observed on the microstructure which resulted in Figure 6-8 and the SEM image on Figure 9. From this area, the microstructure on good surface to the inside and fractured surface can be observed.

Figure 10: Observation area of microstructure and SEM image marked with a red dotted line

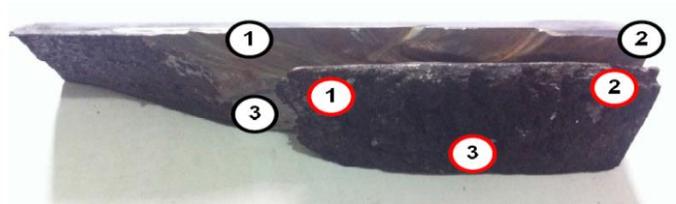
Hardness test is carried out on the surface of the specimen that is still intact and on the surface of the fault. The location of hardness testing is shown in Figure 11 while the results of the hardness test in Rockwell scale are shown in Table 3.

Based on Table 3, the failed surface has a high level of hardness. The increase of the hardness may be an indication of the decreasing ductility of material in this area, and also may be a strengthening mechanisms. The decreasing ductility of material results in the lower load carrying ability of the material. From the visual surface of the spur gear fracture, it can be seen that the failure initially start with high deformation.

Figure 11: Hardness testing area
