Destructive and Non-Destructive Assessment of Collapsed Structures in Onitsha, Anambra State, Nigeria

Ezeagu, C. A.^a, Udebunu, J.N.^b, Obiorah, S. M.O^c

^{a,b,c}*Department of Civil Engineering, Nnamdi Azikiwe University Awka, Anambra State, Nigeria.*

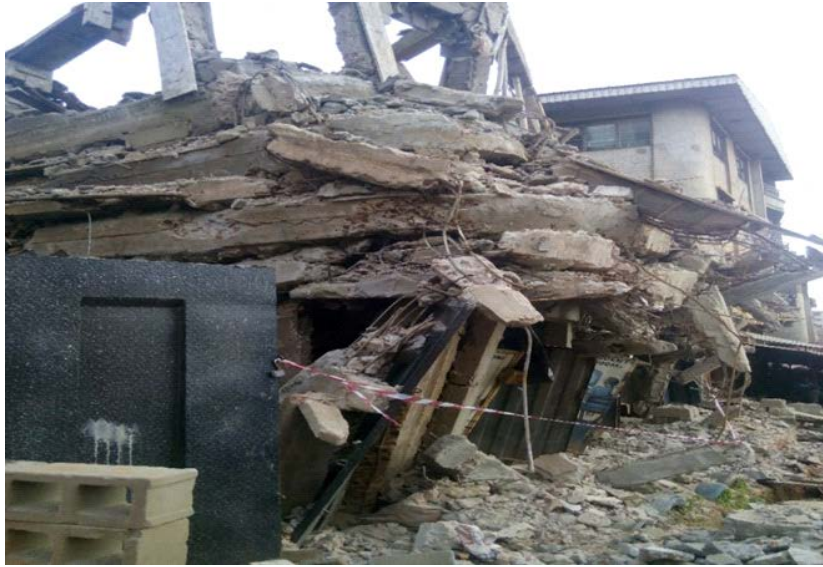
PLATE 1: COLLAPSED 5 STOREY BUILDING AT NO 8 ALLOY OFFIA CRESENT MGBUKA NKPOR ONITSHA ANAMBRA STATE, NIGERIA.

6.1 Discussion on Causes of the collapse for at no.8 Alloy Offia crescent Mgbuka Nkpor

The building located at no 8 Alloy Offia crescent was under construction, at the fifth floor lintel level collapsed in the morning of Saturday, 5th July 2014 suddenly collapsed injuring two workmen at the site, and no death was recorded. This collapse causes include:-

- a. Poor quality concrete mix and compaction methods used for works.
- b. The reinforcements bars sizes used for the columns were not to specifications. 4M12 bars used.
- c. All the top and bottom beams were either under or over reinforced with 2M16bars.
- d. Concrete and steel were inadequately bonded, with non-provision for anchorages in some cases.
- e. Slabs not properly reinforced, top reinforcements not provided to take care of negative bending moment at the support.
- f. Uneven distribution of loads, columns and beams were put in random positions with inadequate reinforcement which lacked continuity in transmitting loads to the foundation.

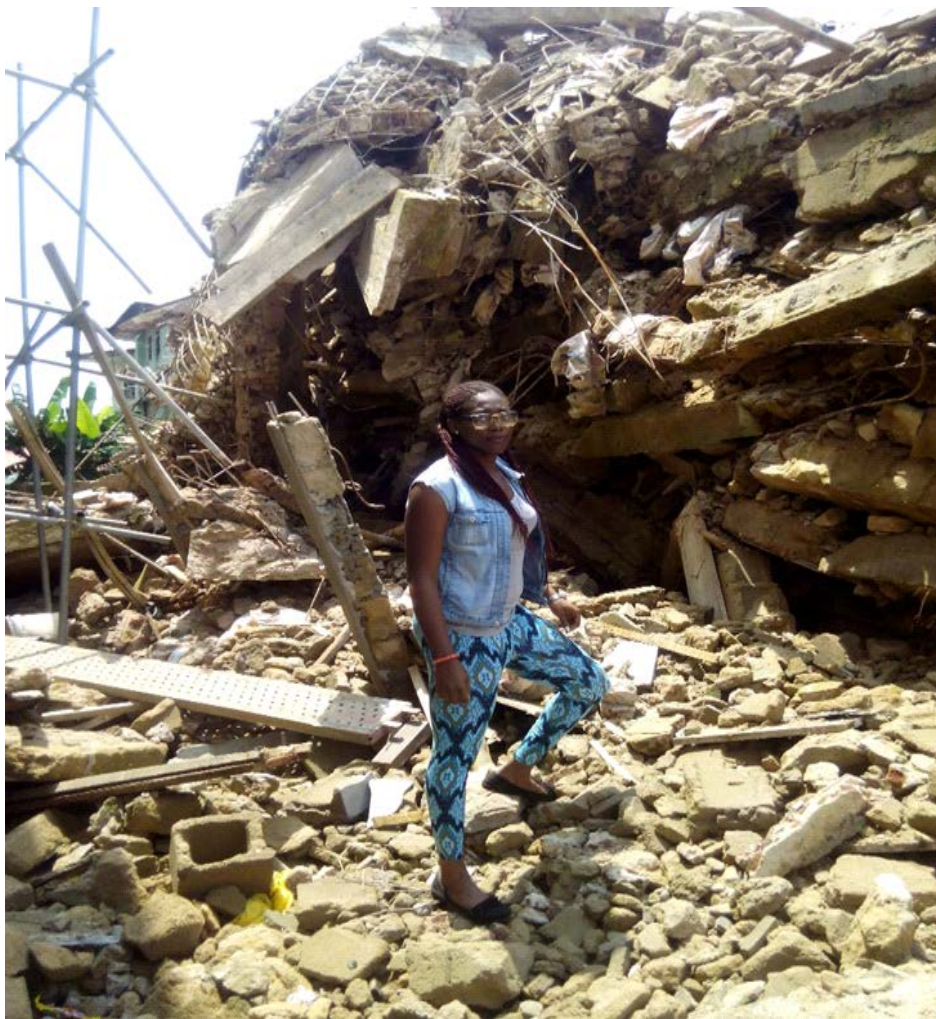
PLATE 2: COLLAPSED 5 STOREY BUILDING AT NO. 10 UDI OBANYE STREET FEGGE ONITSHA ANAMBRA STATE, NIGERIA.

6.2 Discussion on Causes of the collapse for at no.10 Udi Obanye street fegge

As the formworks of the floor where beam removed, the fifth floor fell directly on the fourth floor, it was such that the beams of the collapsed floor were lying directly on the beams of the lower floor. The owner of

the building disobeyed instructions given by the Anambra state government on stoppage of work until after recertification of the construction drawing.

- a. The columns were badly reinforced with large voids at bases, creating gap before the foundation.
- b. Demolition of the old structures where necessary restricted freedom of construction resulted in bad workmanships.
- c. Some columns were inadequately reinforced
- d. Poor quality concrete mixes were used for the works.
- e. No resident supervision for the project.
- f. The concrete in various sections of the slabs, beams and columns was weak. The blocks used had compressive strength of 0.6N/mm^2 . it was obvious that no quality control measures were taken.

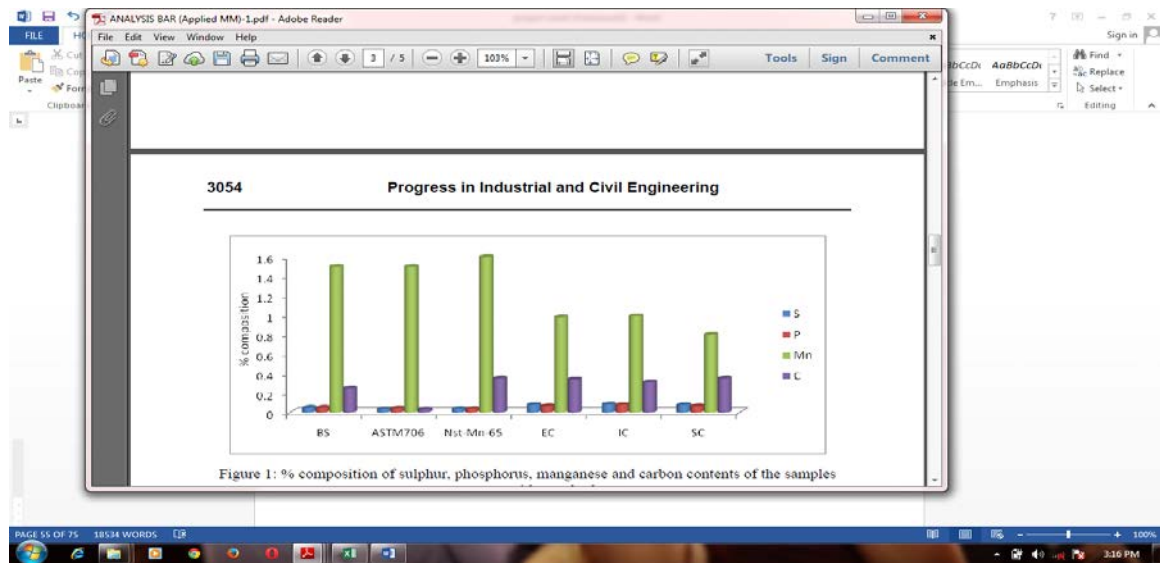
Figure 1: % composition of sulphur, phosphorus, manganese and carbon contents of the samples compare with standards.

The carbon contents of the investigated reinforcing steel bars from the collapsed building sites surpassed the BS4449 and ASTM706 maximum limits of 0.25 and 0.30 carbon requirement for such steel bars but they are in close range with the Nst-65- Mn standards. Thus, the bars are harder than the recommended standard by BS4449 but not as hard as that of Nst-65-Mn standard even though their carbon content is in close range. This may be due to combined effects of other constituent elements of the bar. The phosphorus and sulphur impurities in the investigated reinforcing steel bars exceeded the standards, leading to increased hardness and strength, and decreased ductility, and thus making the bars brittle. The brittleness may be due to the formation of FeS and Fe₃P, which are brittle compound.

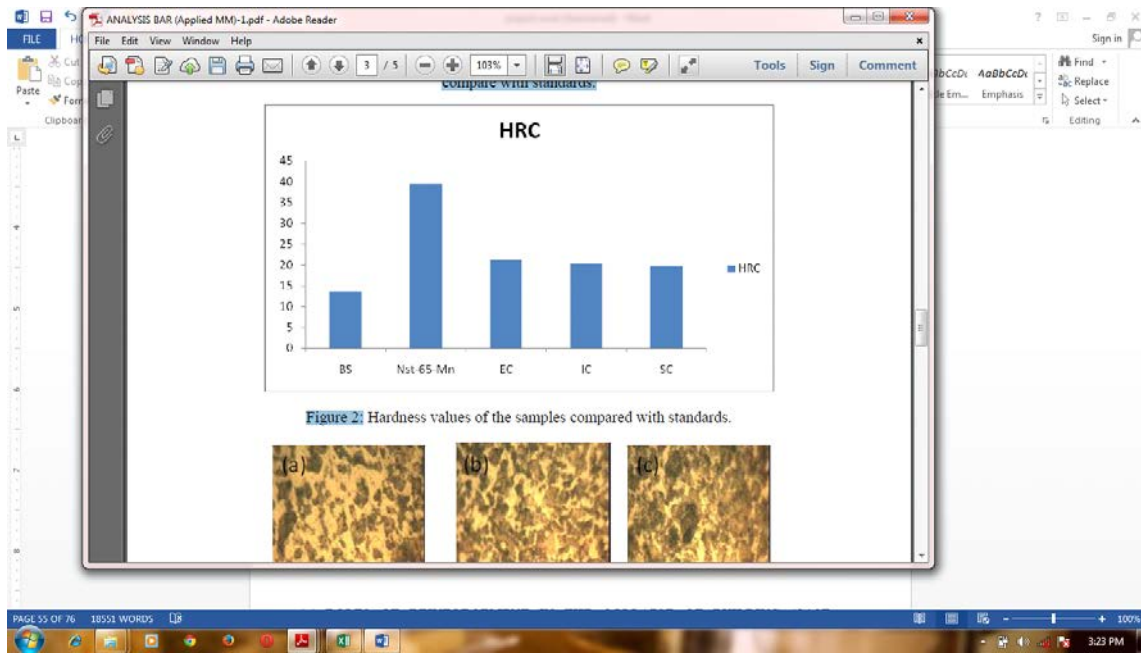
Figure 2: Hardness values of the samples compared with standards.

Samples of reinforcing steel bars were obtained from three collapsed building site in Anambra State. The areas are Mgbuka Nkpor (EC), Fegge (IC) and Odoakpu (SC) in Onitsha, Anambra state. The major samples were 12mm diameter reinforced steel bars. The chemical compositions of the samples were obtained using optical emission spectrometer. Brinnel hardness testing machine was used for the hardness test. The chemical compositions of the samples are presented in Table 7. Figure 1 shows the phosphorus, sulphur, manganese and carbon content of the samples investigated comparing them with BS4449, ASTM706 and Nst-65-Mn standards. The results obtained from Brinnel hardness test are 21.19HRC for EC, 20.22HRC for IC and 19.63HRC for SC. These values are compared with BS4449 and Nst-65-Mn standards and presented in Figure 2.
