Behavioral Study of Shear and Flexural Strength of Reinforced Concrete Beams with Interfaces of Concrete Casted Under Cyclic Loading

Abstract

Keywords: Shear Strength; Flexural Strength; Concrete interfaces; Reinforced Concrete Beams.

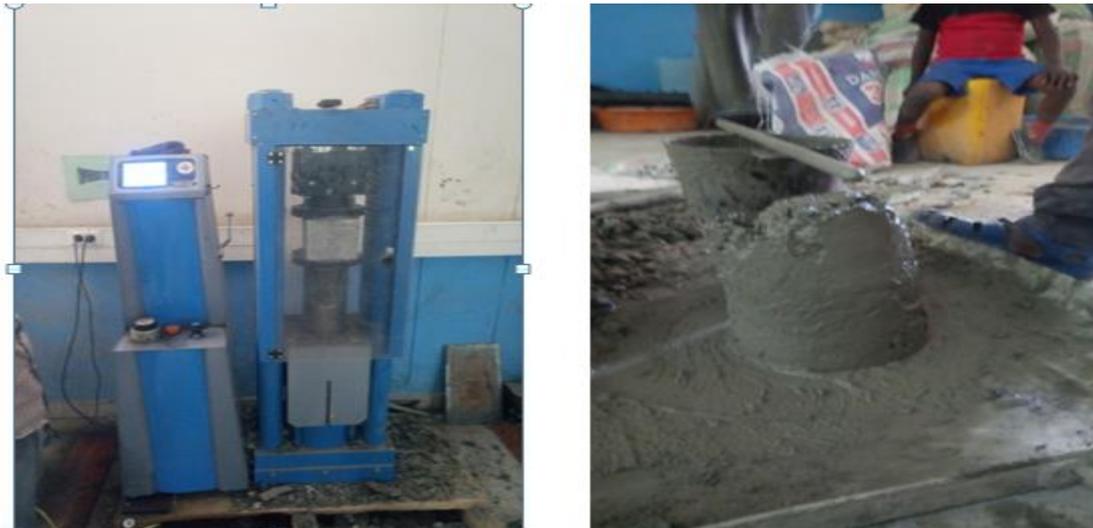
Figure 8: Setup of compression test machine and workability (slump test).

A 150mm cubes specimens were prepared and tested using a compression testing machine shown in Figure 14 below. The maximum load achieved was used to calculate the ultimate stress of each cube. Concrete compressive strength test results for different ages are listed in the following table (Table 2).

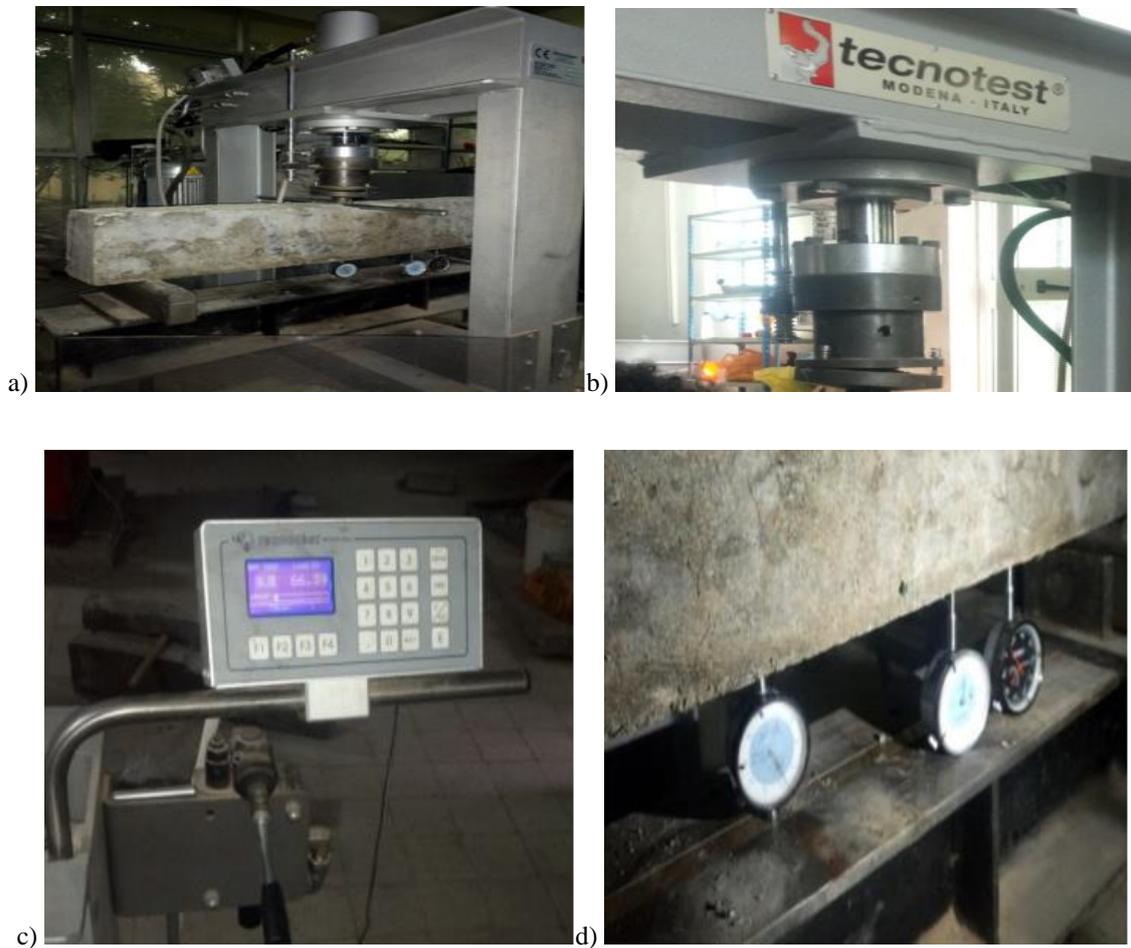
Figure 10: Flexural testing machine a) Full setup b) Loading piston c) Digital load reading cell d) Dial Gauges.

All beams were fully instrumented to measure the applied loads on the beams and the deflections. In brief, the instrumentation consisted of a load cell which measures the applied load (shown in Fig 10), deflection measurement tool dial gauge (shown in Fig 10) for the mid span and other critical-points.

As it was mentioned earlier, the load was applied monotonically in the interval of 5KN on the beam by using a loading piston on a long transverse steel rod up to failure. The deflection also measured by a manual displacement reading machine (Dial Gauges) with an accuracy of 0.01mm placing on the proposed positions.

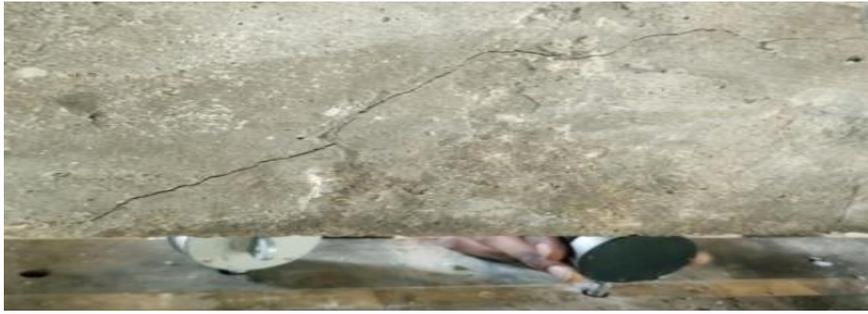
Figure 11: mode of One-third spanned vertical interface shear beam (SB-V1/3).

A one-third span vertical interface shear critical beam (SB-V1/3) also failed by diagonal tension failure modes, because the test specimens were designed to fail in shear, the ultimate shear strength of the beam specimens was governed by web reinforcement provided. The primary crack started at the interface of the concrete (see Figure 11), but the crack didn't continue with the proposed line of interfaces, rather it follows the diagonal tension crack direction. Finally the opening of this diagonal tension crack becomes excessive, and then the beam failed.

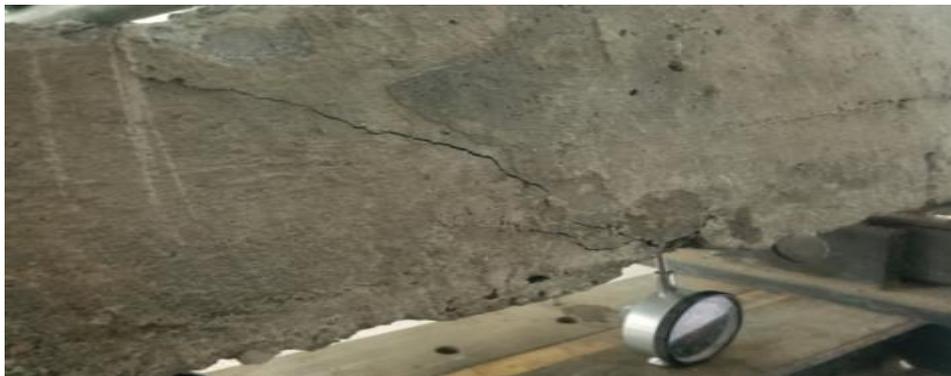
Figure 12: mode of Quarter spanned vertical interface shear beam (SB-V1/4).

The same behavior was observed for quarter span vertical interface shear beam (SB-V1/4), the primary shear cracks initiated at the interface (see figure 12). Gradually this crack directed to the loading point. An increase in applied load opens the primary crack excessively. Finally the beam reaches its ultimate carrying capacity, the concrete on the top of loading point and bottom of the interfaces crashed out.

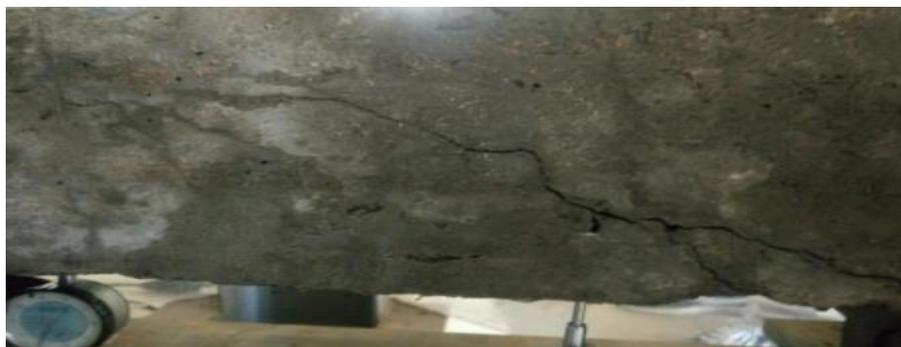
Figure 13: Failure mode of One-fifth spanned vertical interface shear beam (SB-V1/5).

For the one-fifth span vertical interface shear critical beam (SB-V1/5) as shown in figure 13 the primary crack starts near to support, which is at the interface location. This shear crack becomes wide and excessively opened and finally the beam to fail in diagonal tension failure which is the crack directed from support to the mid span or the loading point.

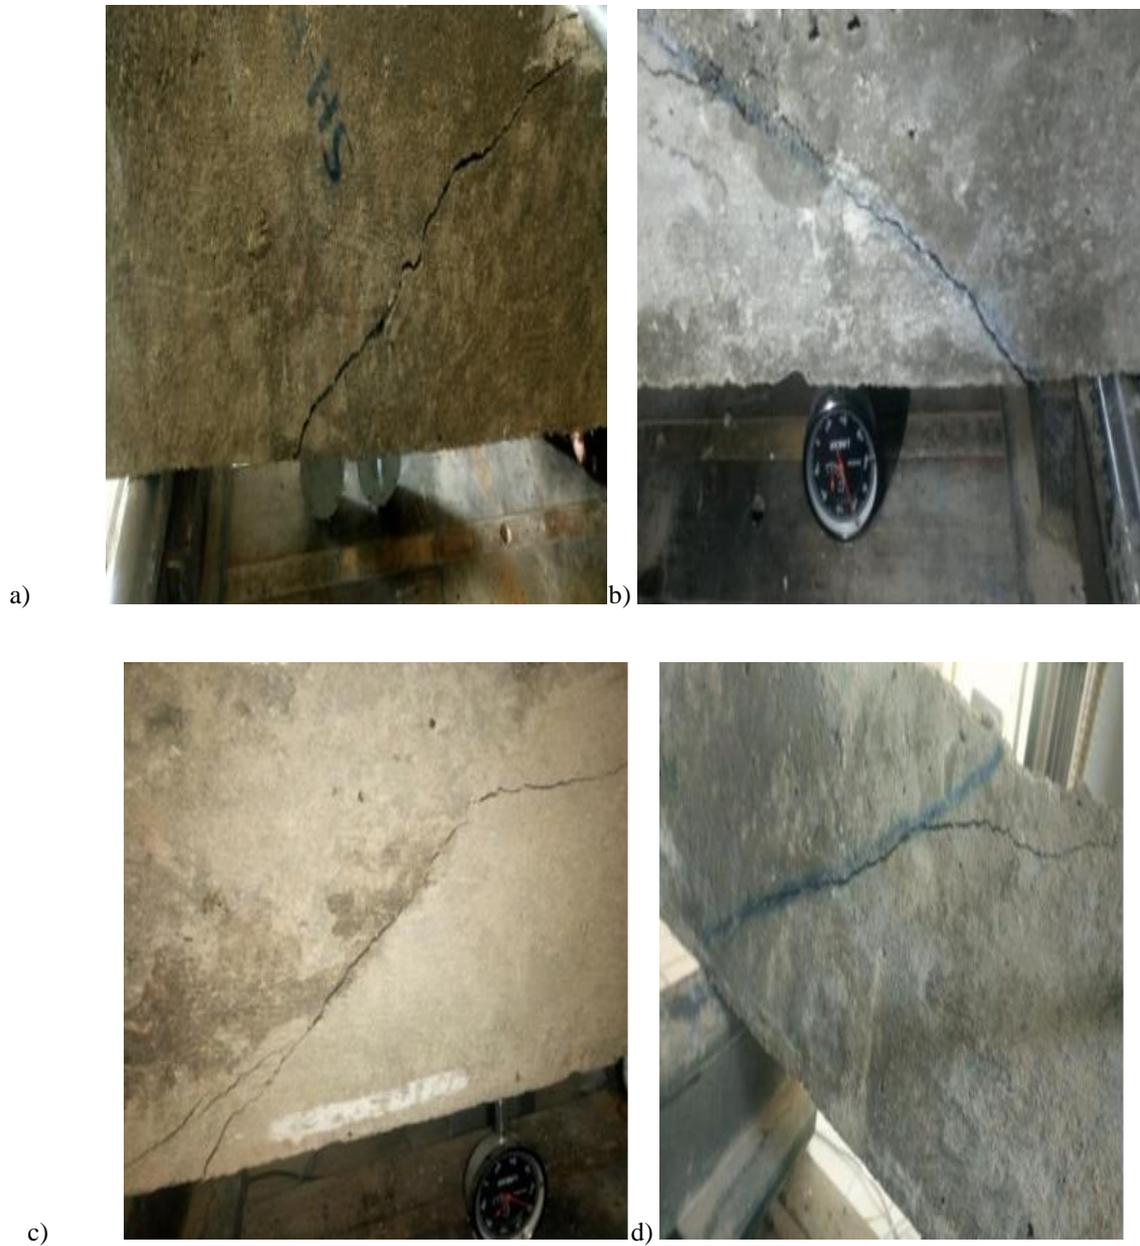
Figure 23: Crack pattern of diagonally casted shear beams; a) CSB b) SB-I1/3 c) SB-I1/4 d) SB-I1/5.

Unlike the vertical interface shear beam, all the beams with diagonal interfaces were exhibits similar failure modes. The primary shear crack initiated from the interfaces. Figure 23 shows the patterns of the crack is along the casting configuration. As stated by [15] Diagonal tension failure governs the current specimens, the propagation of cracks follows the formed interfaces which are weaken joint. This indicates that a significant effect is observed on the presence of interfaces in reinforced concrete beam.

The load carrying capacities of all the three diagonal interface beam specimens for resulted 51.87KN, 48.21KN and 44.84KN respectively. The results indicated that a decreases in the load capacity of 12.95%, 19.09% and 24.75% as compared with the control beam. But when we compare the results with vertical interface beams, it gives better shear capacity.

- An inclined or diagonal interface of beam specimen's results shows that the crack pattern follows the direction of the interfaces, whereas the crack patterns didn't follows the direction of interfaces for the vertical interfaces beam specimens.

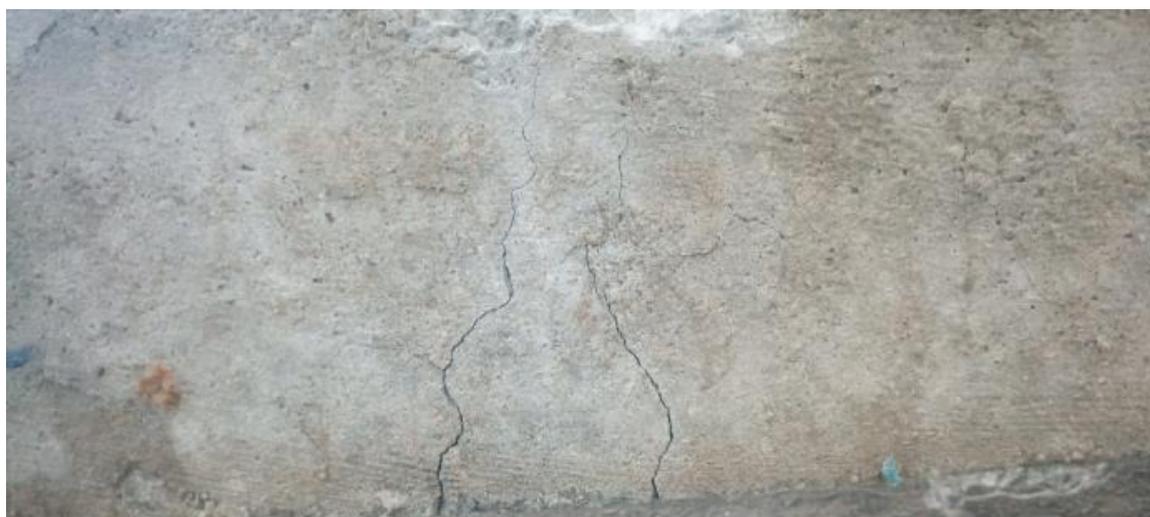
Figure 18: Flexural cracks for control flexural beam (CFB) specimen.

In flexural beam specimens casted monolithically (CFB) figure 18, small flexural cracks first appeared on the bottom of beam section along the concentrated loads, where the flexural stress is highest and shear stress is zero. Because the test specimen was designed to fail in flexure, the ultimate flexural strength of the beam specimen was governed by the yielding of tensile reinforcement in the bottom region and crushing of concrete in the compression zone. Therefore, as loading increased, those small flexural cracks opened excessively, finally the beam failed reaching its ultimate capacity.

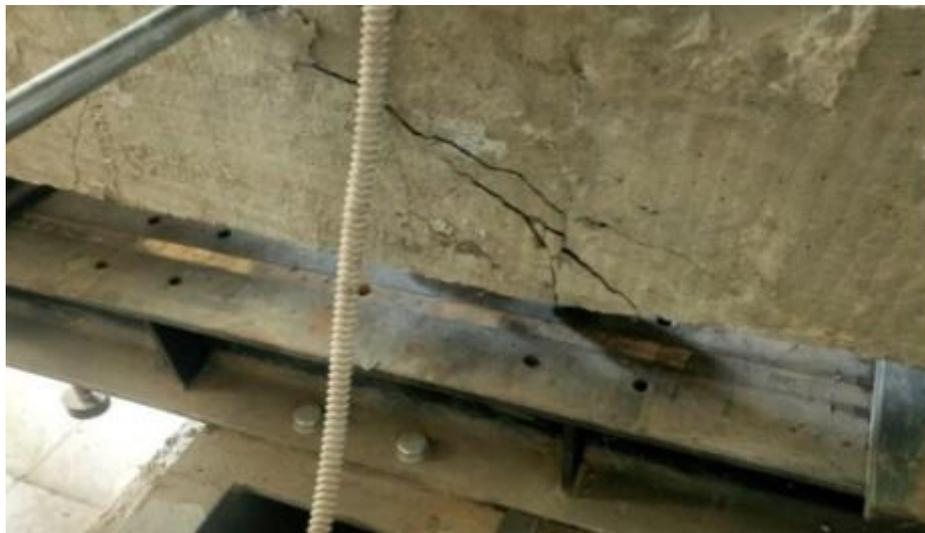
Figure 19: Failure of Quarter flexural beam (FB-V1/4) specimen.

For quarter span casted flexural beam (FB-V1/4) figure 19, small flexural cracks initiated at the mid span of the beam. Unlike the other flexural beam specimens, a sudden propagation of diagonal crack was observed starting from the interface formed. This crack becomes wider and the beam goes up to maximum carrying capacity, finally the beam failed. In this beam, it was found that the load was decreased dramatically and failed with small amount of loads. As can be seen in the figure the failure mode was not flexural failure rather its failure was shear-flexural failure, such kind of uncertainty occurred in this specimen only.
