Evaluation of Safety Performance of Fractured Joints in Steel Truss Bridge

Abstract

Keywords: highway bridge; HSFG bolts; modes of failure.

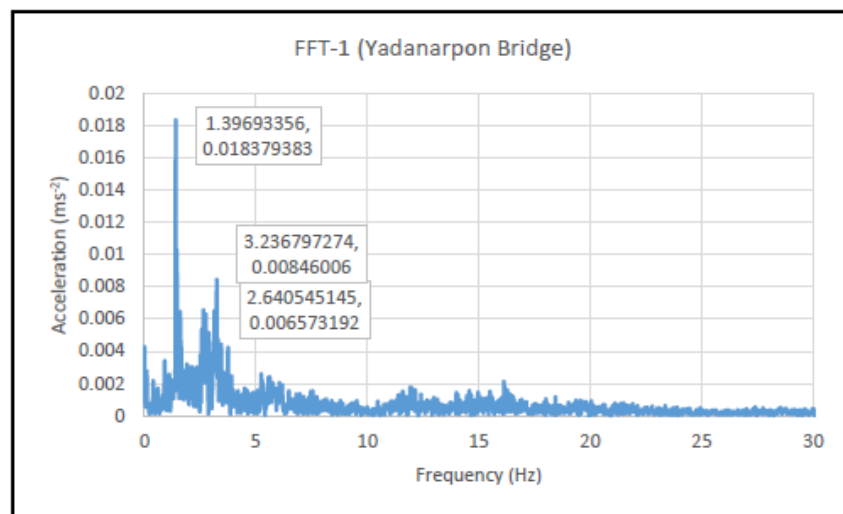
Figure 5: Example of FFT graph for Yadanarpon Bridge

- The fundamental frequencies of some modes of the bridge were found to be around 1.4 Hz, 2.6 Hz and 3.2 Hz by converting the vibration data to FFT graphs (see Figure 5).
- The average values for the wind speed, temperature, relative humidity and atmospheric pressure were measured as 1.9 m/s, 32.6°C, 62.8%, 996 hPa respectively.
- Bolt axial forces are shown in Table 5. According to the Japanese standard and AASHTO, the introduced bolt axial force for bolt of which diameter is 24mm and strength class is F10T or 10.9 should be 238kN and 257kN respectively. Bolt axial force of Bolt 3 and 4 are less than the other bolts due to corrosion (see Figure 6).

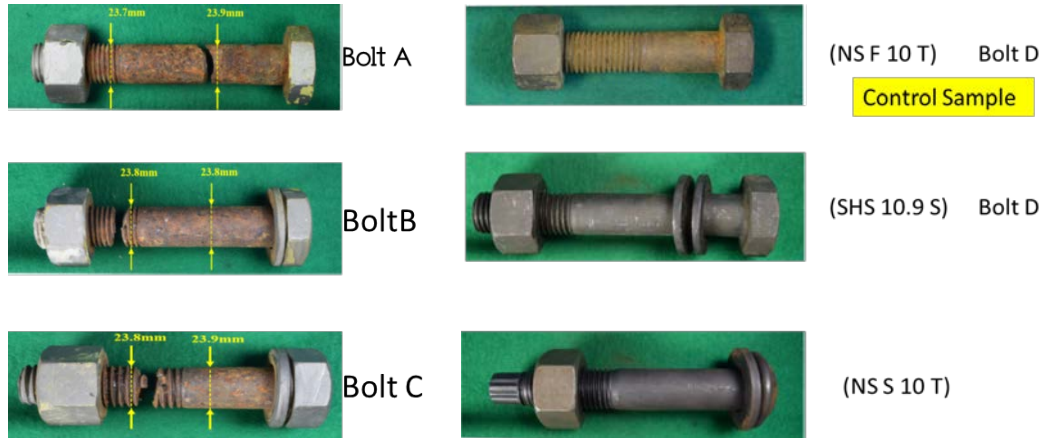
Figure 7: Samples of high strength bolts

Radial fractures occurred in the cylindrical part of Bolt A and in the thread root of Bolts B and C.

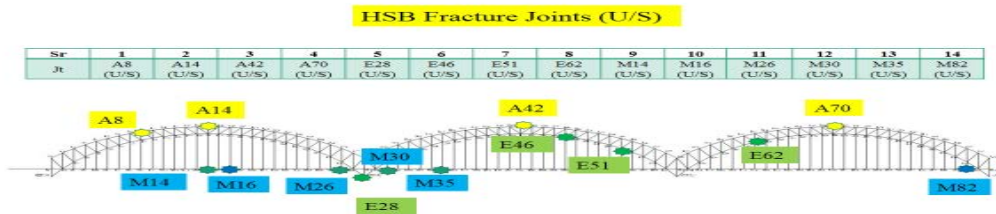
Figure 20: Considered fractured joints of arch bridge

Safety performance of fractured joints illustrated in Figure 20 are calculated based on analysis results of Midas Civil. A8, A14, A42 and A70 shown in yellow color are top chord joints. E28, E46, E51 and E62 of green color are bottom chord joints and M14, M16, M26, M30, M35, and M82 of blue color are middle chord joints. Their corresponding safety performance are shown in Table 10. Table 11 shows safety factor and percent fracture of considered joints.
