An Investigation on the Premature Failure of Spur Gear in Coal Stacker Reclaimer: Mechanical Properties and Microstructure Analysis

Abstract

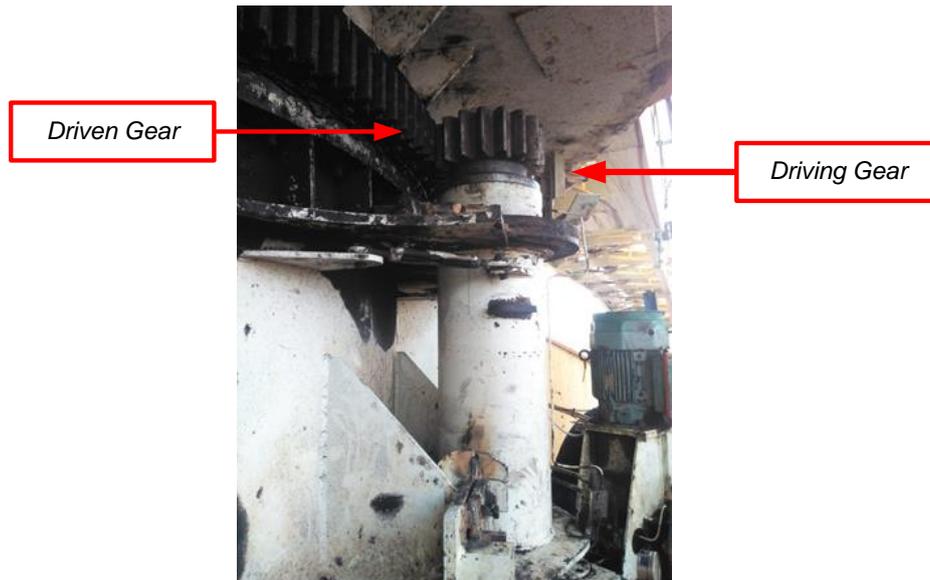
Figure 1: The position of driven and driving gear on stacker reclaimer

In this paper, the premature failure of the spur gear on the coal stacker reclaimer system is reported. Fault failure that occurs in the driving spur gear (see Figure 1). The failure is located in one of the teeth at the upper side of the root and propagates until the upper part of the gear is broke. The fault occurs when the stacker reclaims work in service, causing material transportation to stop. The constraints of this research are the specimens in the form of spur gear, not discussing the vibration aspect, the test material is the specimen of fracture the spur gear from the slewing gearbox on the stacker reclaimer. The driving gear position is shown in Figure 1 and the failure occurred at the driving gear. Configuration of the pinion spur gear as a driving gear shown on Figure 2 while the dimensions of the spur gears are shown in Figure 3.

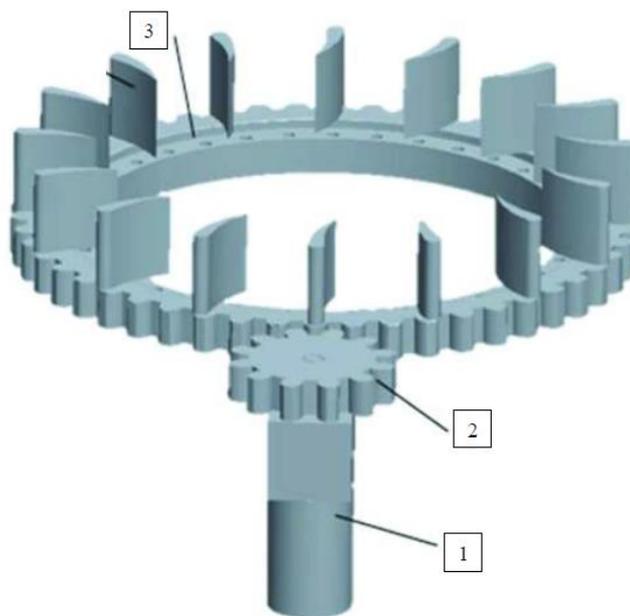
Figure 2: The configuration of: 1) Driving shaft, 2) Driving gear and 3) Driven gear

Figure 2 shows the configuration of driving and the driven gear whereas the precise dimensions of the driving gear is depicted in Figure 3 and Table 1. Based on the pinion gear motion in Figure 2, the force diagram acts on the driving gear related to the direction of the applied load is presented in Figure 4 which can be predicted as the initial/origin of crack propagation which resulted in gear failure.
