Mechanical Properties of Liquid and Solid Repaired on Damaged Model of Glass Fiber-Reinforced Polymer Composites

This study has investigated the effect of repair method on mechanical properties of Glass Fiber-Reinforced Polymers (GFRP). Composite materials are primarily damaged by mechanical loads. In this study, a damaged composite was repaired by liquid filling and solid filling methods. The damaged composite was modeled by drilled composites specimen with 5 mm drill. The specimen than repaired in the form of the same fluid and solid mixture of epoxy resin composite. The tensile and impact properties of damaged and repaired composites were observed. The results show the increase of tensile and impact strength in each additional glass fiber in both liquid and solid repair. Also, solid repair data show the better and the increase of tensile and impact strength than the liquid repair. They are 23, 40 and 46 MPa for tensile strength of solid repair with 10%, 20% and 30% of additional glass-fiber respectively. Moreover, the impact strength data of solid repair show 0.86, 1.00 and 1.99 J/mm² with 10%, 20% and 30% of additional glass fiber respectively. Fractography study shows the fra

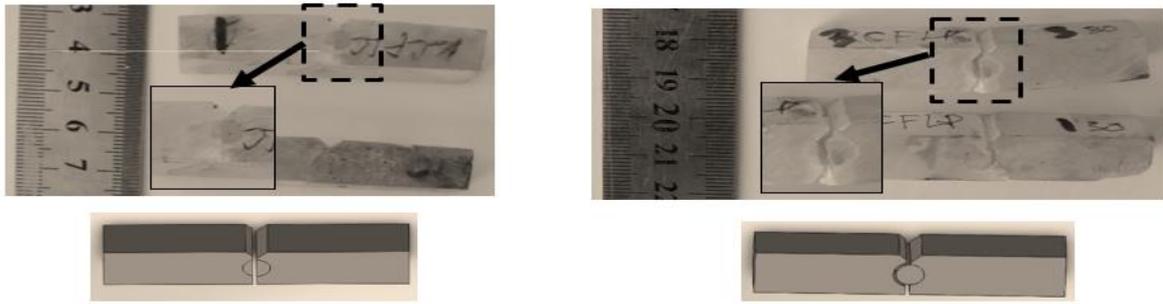
In addition, patterns of impact tests were found in 2 places. Firstly, fracture passing through the middle of the repaired hole were commonly found in the HER, RLHER, RLHGFRP specimens that allow the method of liquid filling. The bond between fiber and matrices is less strong so that stress concentration occurs in this area [5]. While the fracture surrounding the repaired hole was found in RSHER and RSHGFRP specimens. Similar to tensile test specimens, the crack propagates in this area because of the parent material with the solid filling is adhered only by epoxy resin. The epoxy resin bonds empty holes that were initially occupied by fiber and the fiber were pulled out because of the drilling process. The crack propagation is initially started in this area and grows in the same position. As a result, fracture bordering the solid repaired area cannot be denied [3].

Figure 6: Macrophotograph of Fracture at Repaired Composites Impact Tested

4. In the tensile and impact test, it was found 2 patterns of fracture: fracture through the repaired area is found in HER specimens and RLHGFRP 10%, 20%, and 30%. The fracture circling the repaired hole is found in RSHGFRP specimens 10%, 20%, and 30%.
