# Modeling Approach for Earthen Dam Breach Analysis in North Yamar Dam, Myanmar

*Irrigation and Water Utilization Management Department, the Republic of the Union of Myanmar*

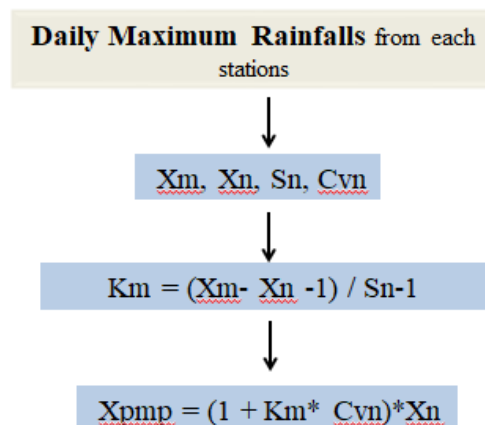
Figure 2: Workflow of PMP calculation.

### 2.2.1. PMP calculation

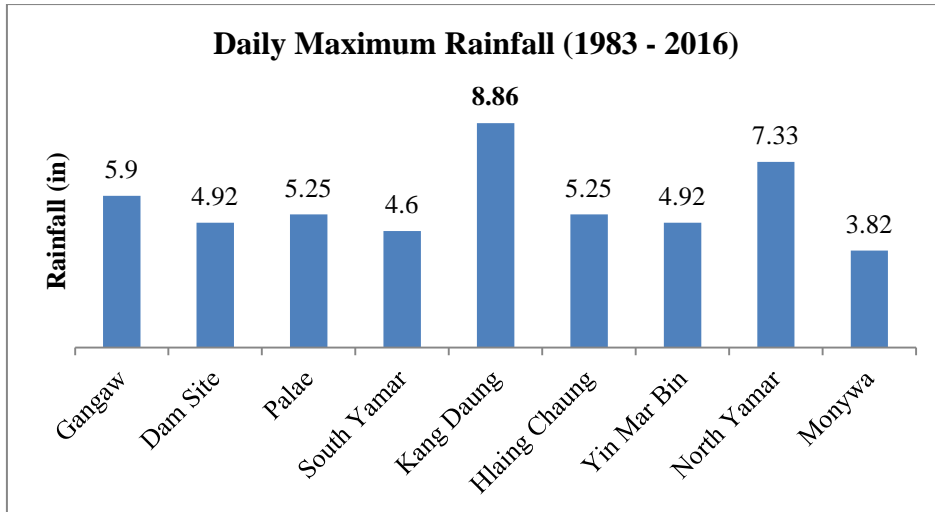
Figure 3: Daily maximum rainfall data from nine stations

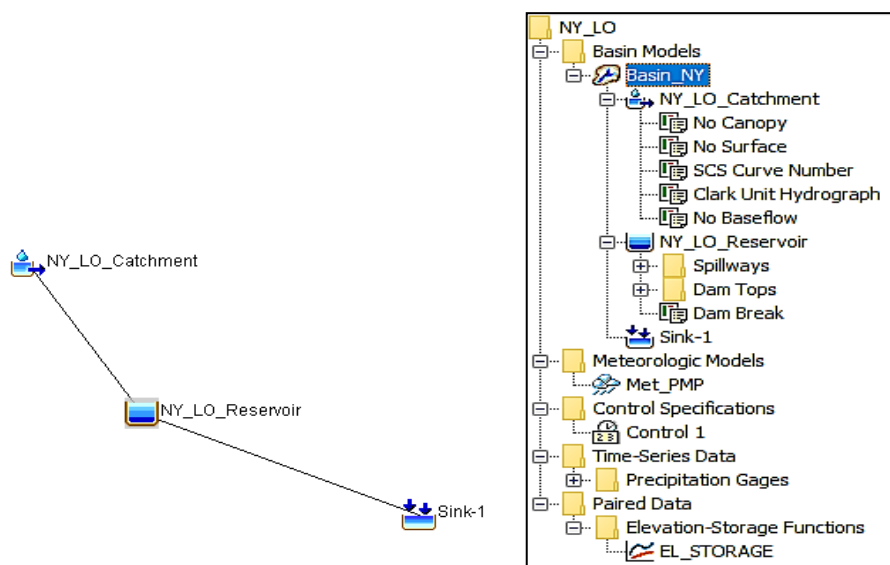
Figure 4: HEC-HMS Model set up

HEC-HMS 4.0 (Hydraulic Engineering Center’s Hydrological Monitoring System) which was developed by the U.S. Army Corps of Engineering was used to create catchment, reservoir and downstream (sink-1) to determine water flow from catchment to the reservoir as shown in Figure 4. The SCS Curve Number method is used to calculate the infiltration and Clark Unit Hydrograph is for calculating runoff. The HEC-HMS model required the following input data for reservoir routing. : (1) time-series data: precipitation data and discharge data of selected durations, (2) reservoir elevation-storage relationship data, (3) reservoir and spillway information for North Yamar dam [9]. In this study, the regression equation of Froehlich-1995a for overtopping and Froehlich-2008 [10]for piping was used to calculate breach parameters such as bottom width of breath and time of failure as suggested in training document by U.S. Army Corps of Engineers [4].

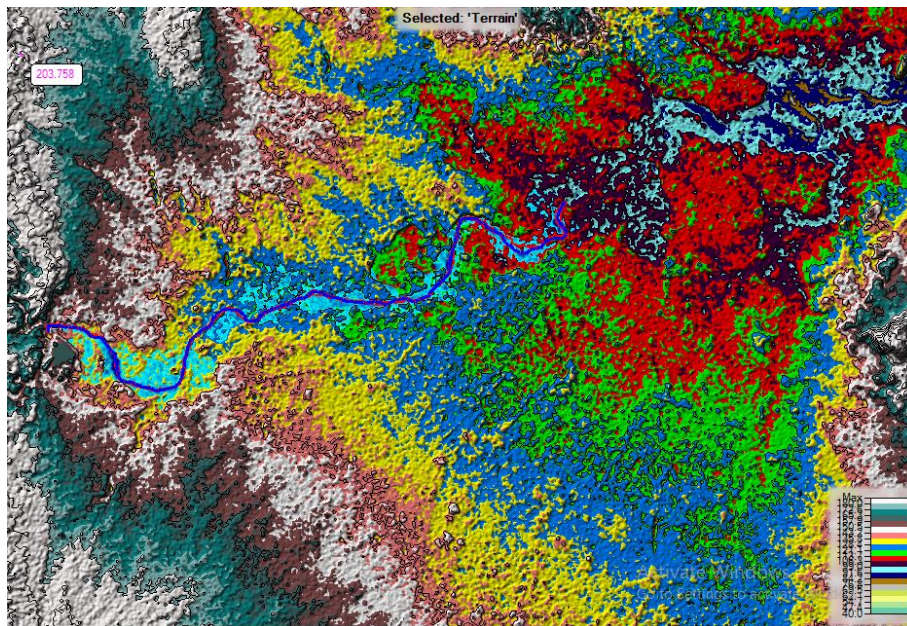
Figure 5: North Yamar Terrain in RAS-Mapper

HEC-RAS 5.0.7 (Hydraulic Engineering Center's River Analysis System) is free downloadable software which was developed by Hydrologic Engineering Center of the U.S. Army Corps of Engineering[11]. The 30 m resolution ASTER GLOBAL DEM downloaded from USGS Earth explorer website (<http://earthexplorer.usgs.gov/>) was imported into RAS Mapper and the terrain was created and overlain Google Satellite in HEC-RAS as shown in Figure 5. This served as the working layer in generating the geometry of North Yamar River network. Using the geometric data tool of HEC-RAS, River, Bank lines and Cross sections were drawn in RAS Mapper as in Figure 6. The cross-section data is automatically entered into HEC-RAS from start of river up to 26.5 km. The Manning roughness coefficient value is assumed to be 0.025 for bed channel and 0.04 for river banks since the natural streams which has rocky river beds with grass banks usually steep, trees and brush along banks has manning roughness coefficient in the range of 0.03 to 0.05 [12]. Then unsteady flow analysis is done for the mixed flow regime with the boundary conditions incorporated as outflow hydrograph from HEC-HMS, normal depth as 0.01 and computation interval 30 second. Then the model is run one by one for the unsteady flow analysis file with the failure mode overtopping and once piping. Further the detailed output table can be viewed in view section and the velocity in channel, water surface elevation, discharge, and energy gradient level and be observed for each station. Then floodplain layer is generated by RAS Mapper. Thus the shape file of floodplain area can be viewed on map and more hazardous zone can be

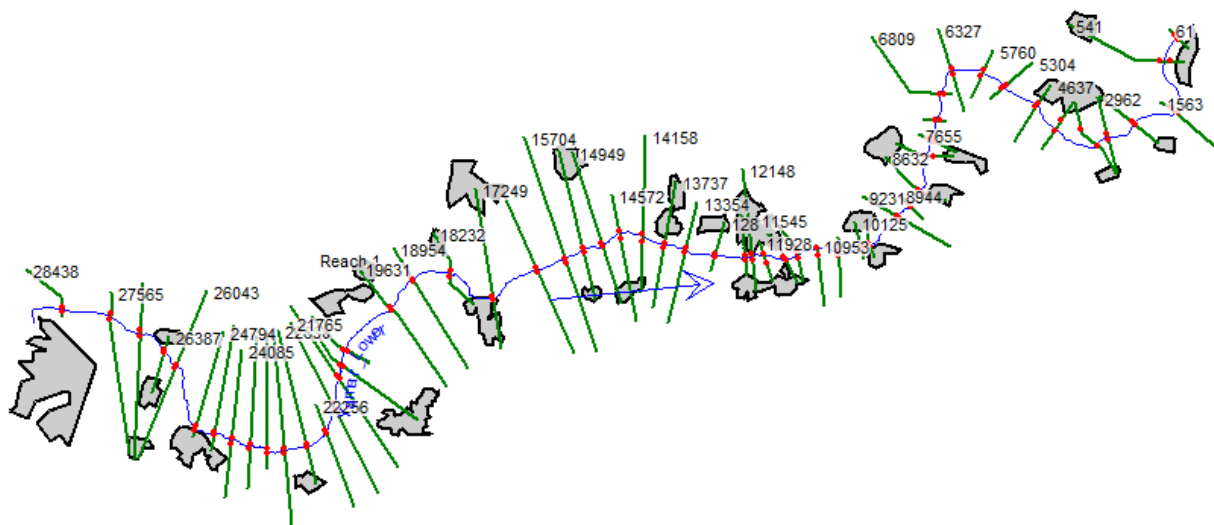
Figure 6: Geometrical view of North Yamar River in HEC-RAS

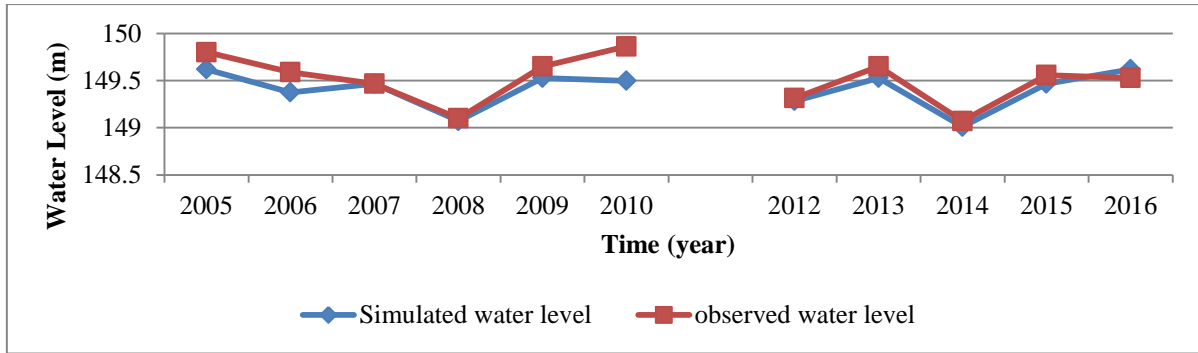
**Figure 7:** Comparison between simulated and observed spill elevation

In model calibration, the elevation spilled discharge relationship data for 2005 to 2010 and 2012 to 2016 from North Yamar Dam are compared with simulated stage –discharge relationship. The HEC-HMS model was used to estimate possible maximum peak elevation from spillway for each year and compared the observed peak elevation (Figure 7). Probable parameters from the model are adjusted during calibration to obtain the satisfied coefficient of determination ( $R^2$ ) value (0.78) as shown in Figure 8.

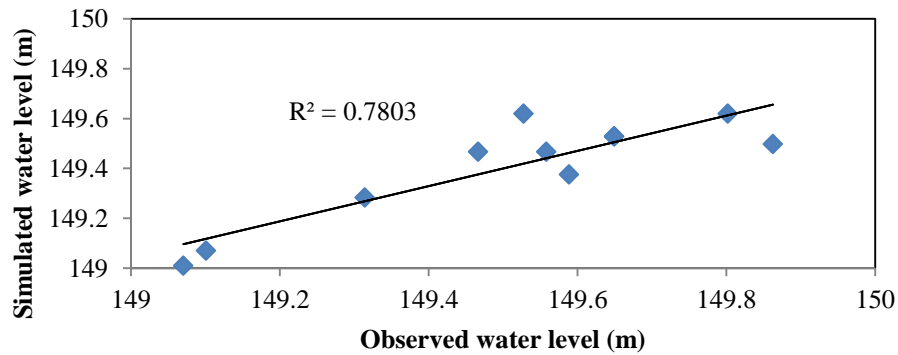
**Figure 8:** Comparison between simulated and observed spill elevation

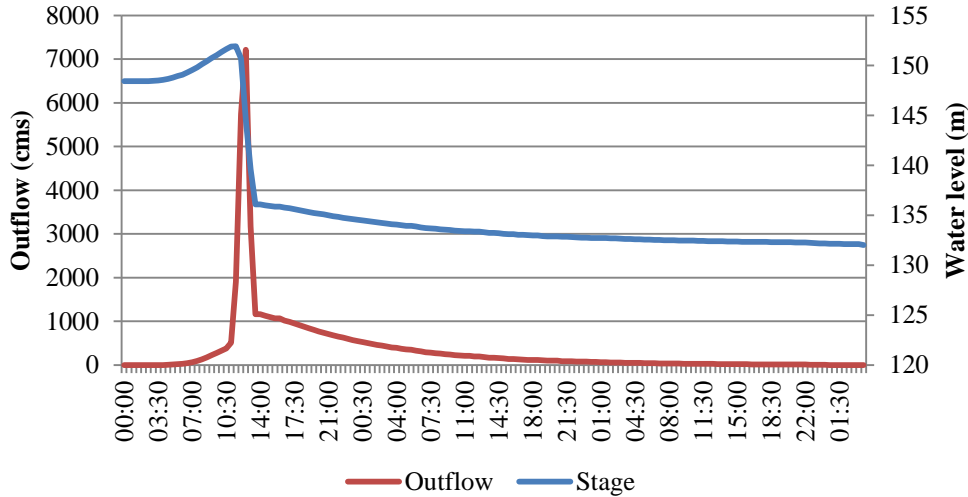
Figure 9: Without emergency spillway on overtopping failure.

In this scenario, the results of overtopping failure mode were compared by with or without emergency spillway in modeling of breach outflow hydrograph in HEC-HMS. Without emergency spillway, dam breach occurred with the peak discharge 7,211 m<sup>3</sup>/s and peak elevation 151.9 m as shown in Figure 9. No dam break occurs if there is an emergency spillway. Flow emerges into 151.23 m with magnitude 1,120.36 m<sup>3</sup>/s and descends again as shown in Figure 10. In piping failure mode, no significant effects resulted in both scenarios of with and

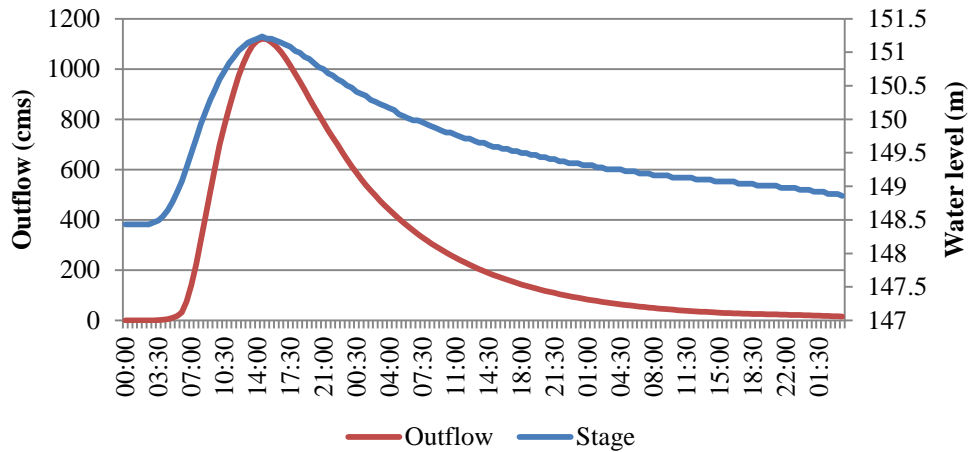
Figure 10: With emergency spillway on overtopping failure

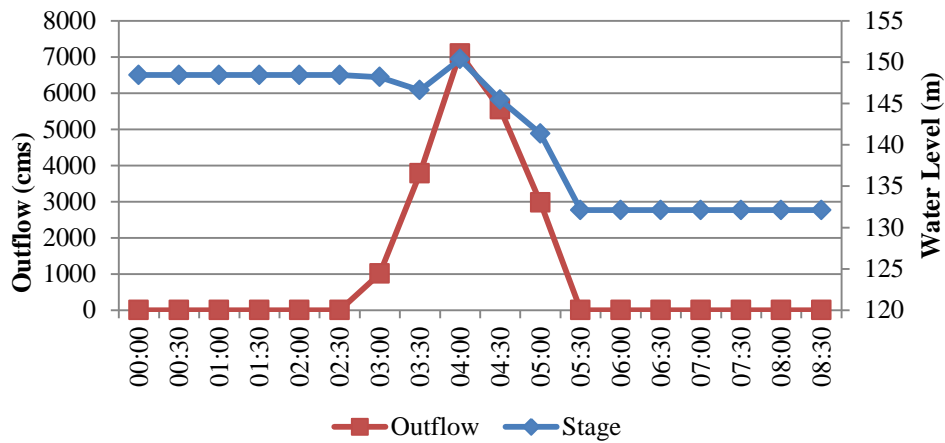
**Figure 11:** Piping at near Toe (R.L – 135 m)

In this scenario, sensitivity of dam break model is analyzed by changing piping elevations and keeping constant the other parameters. When piping elevation is at the first berm (R.L – 144 m), the peak discharge is 3,805.79 m<sup>3</sup>/s with elevation – 148.43 m (Figure 12) and when piping elevation is at the near toe level (R.L – 135 m), the peak discharge is 7,090.68 m<sup>3</sup>/s with peak elevation – 150.35 m (Figure 11). The result showed that piping at lower elevation resulted in higher peak discharge and elevation. So, with the change of piping elevation, there is significant increment of peak discharge and increment peak water level along the downstream location is observed. Previous study by Hajime and scientists from Kyoto university also showed that the vertical location of piping have significant effects on magnitude and occurrence of peak discharge at their experiment in 2011 [13].

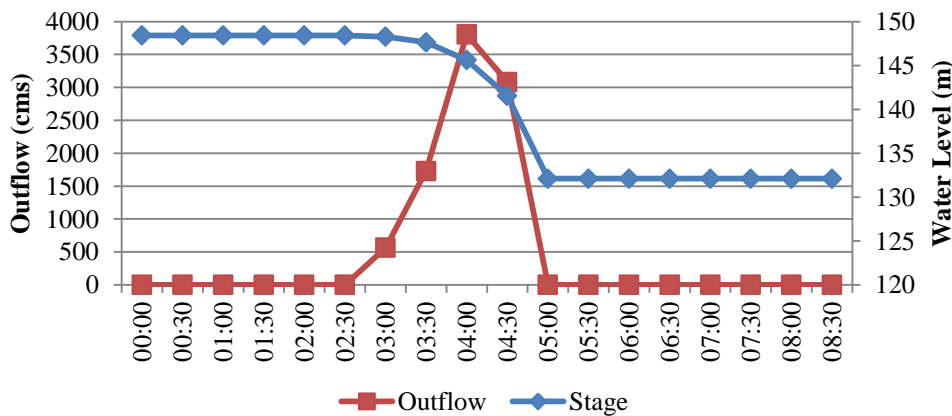
**Figure 12:** Piping at first berm (R.L – 144 m)

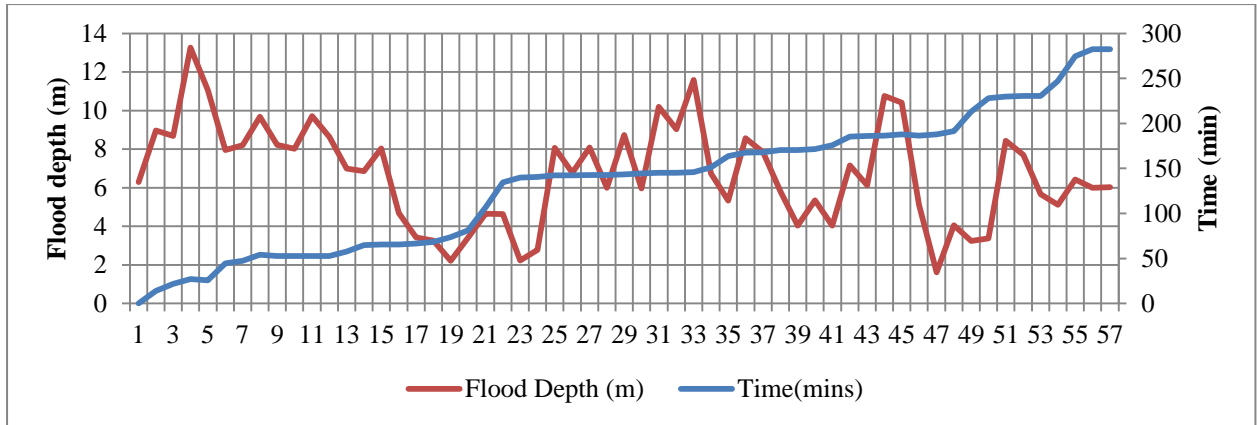
**Figure 13:** Maximum Flood Depth and Arrival Time for piping at bottom failure

Inundation mapping of North Yamar Dam was taken in account only for piping failure mode because overtopping failure will not occur according to the present spillway situation of North Yamar Dam and according the analyzed scenario results. The potential piping analysis at R.L – 135 m was considered to be the worst piping breach for North Yamar Dam and inundation maps for that was evaluated for downstream consequences. Figure 13 shows arrival time and flood depth of North Yamar dam break by piping at bottom

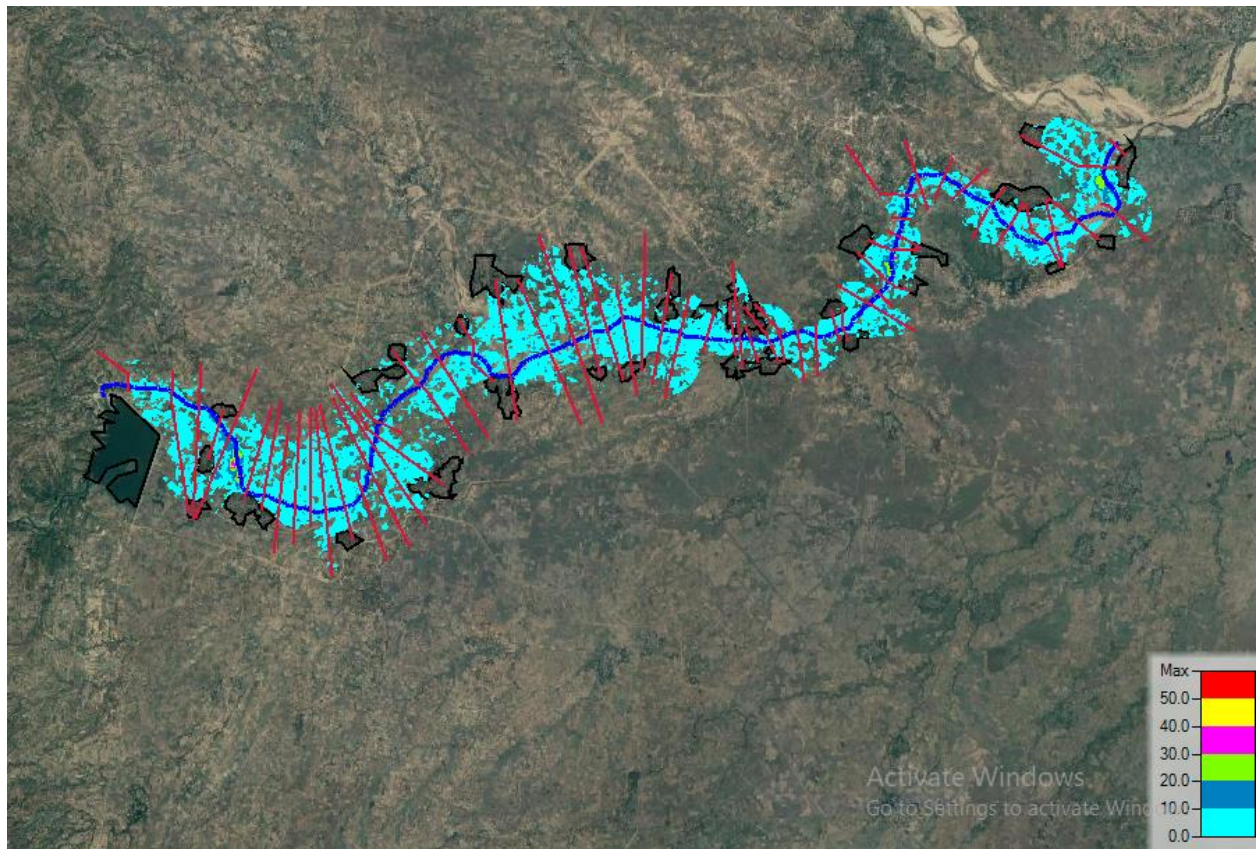
**Figure 14:** Flood inundation map of North Yamar dam breach by piping failure mode

elevation (R.L- 135 m). Figure 14 shows the flood inundation map of North Yamar dam break by potential piping failure mode which would be used for planning effective and urgent emergency action. Figure 15 shows the selected specific areas which inundation covered due to piping with description of risk measurement parameters. Depending on this condition, authorities could give urgent protective measures. Table 1 shows the maximum water level and arrival time of peak discharge at specified location downstream of the dam for piping mode of failure.

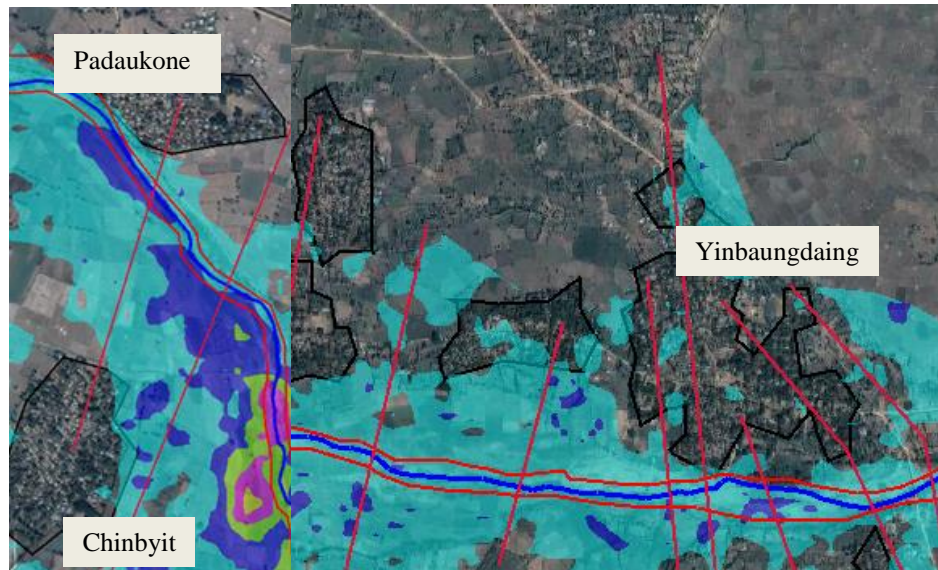
**Figure 15:** Flood inundation map of North Yamar dam break by piping that shows flood coverage over Padaukone, Chinbyit and Yinbaungdaing villages

According to Figure 15 and Table 1, maximum flood depth 13.26 m would occur at 2 km downstream distance 27 minutes after peak discharge happened during breach time. At 2km distance, Chinbyit village and Padaukone village is located on left bank and right bank respectively so that emergency preparedness plan should be taken in account for that two villages. Similar plan should also be prepared for Yinbungdaing village which is 14.46 km distance in downstream and flood coverage would be 10.19 m depth with arrival time 145.2 minutes.
